Complete Streets in the City of Trenton: Existing Conditions Analysis

May 2018

Prepared for:
The Trenton Health Team

Prepared by:
**The Alan M. Voorhees
Transportation Center**
Edward J. Bloustein School of
Planning and Public Policy
Rutgers, The State
University of
New Jersey

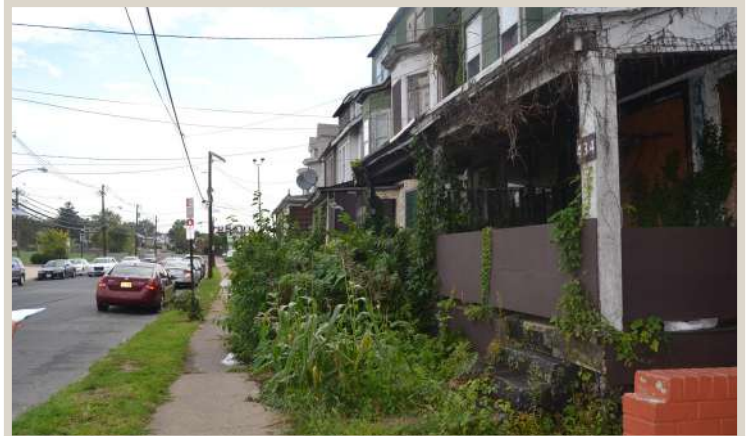
The sidewalk and the homes on the east side of the street are in poor condition. There is a narrow sidewalk in front of homes with vegetation that is overgrown (Figure 19). South of the homes, there are two auto-oriented businesses which have various driveways across the sidewalk. The business at the corner of Brunswick Avenue and Southard Street is a gas station with a continuous driveway.

Figure 19. Overgrown vegetation on sidewalk.

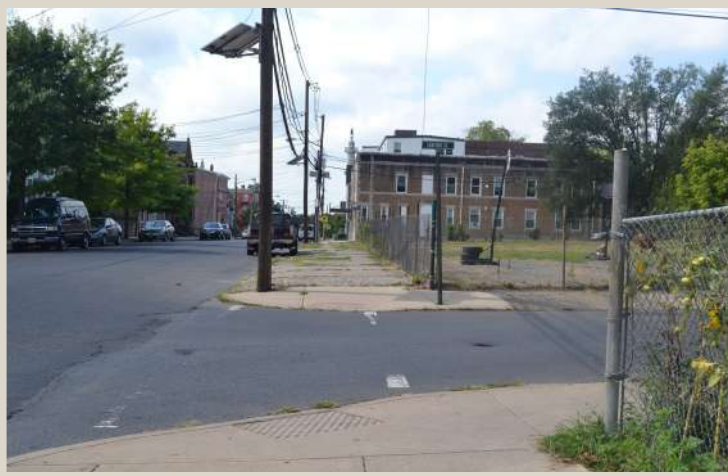
Avenue, is in especially poor condition with a section that has deteriorated into gravel (Figure 20). Across the street, the sidewalk conditions briefly become excellent in front of what appears to be more recently constructed townhomes. The sidewalk is wide with a brick trim and well maintained trees. Two additional minor streets, Cavell Street and Violet Street, terminate at Brunswick Avenue in close proximity.

Figure 20. Brunswick Avenue and Sanford Street. Sidewalk in front of vacant property is in especially poor condition.

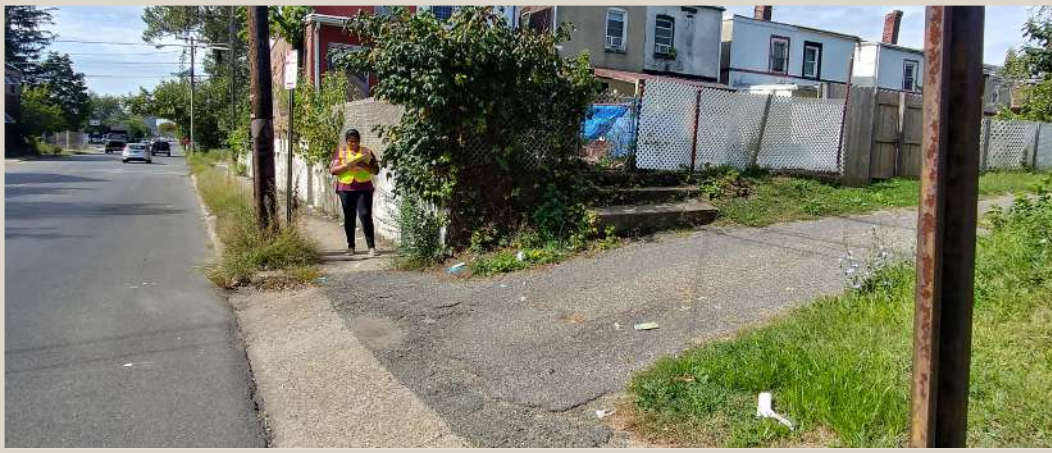
Figure 28. Poor sidewalk conditions north of Blane Alley.

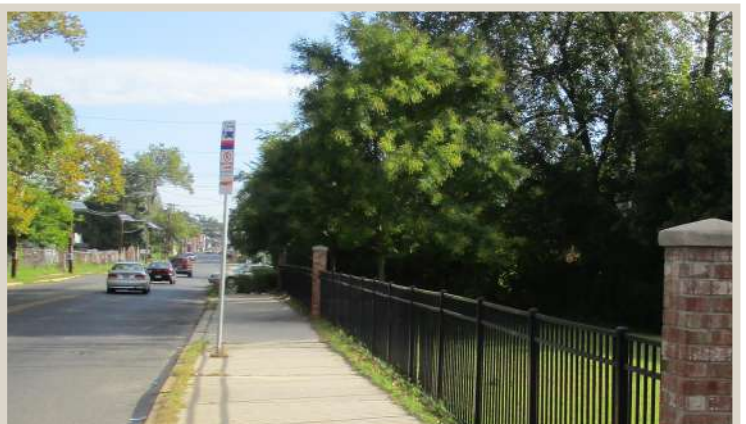
Figure 30. NJ Transit bus stop which lacks rider amenities.

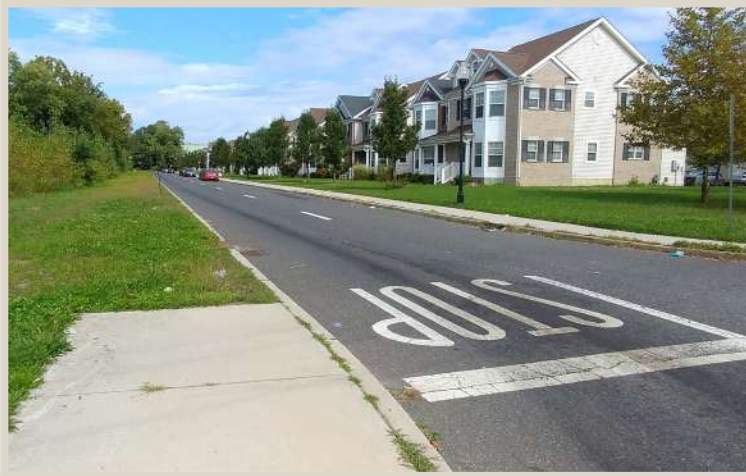
Figure 37. Improper white center striping along Dunham Street indicates that this roadway may be privately owned and maintained.

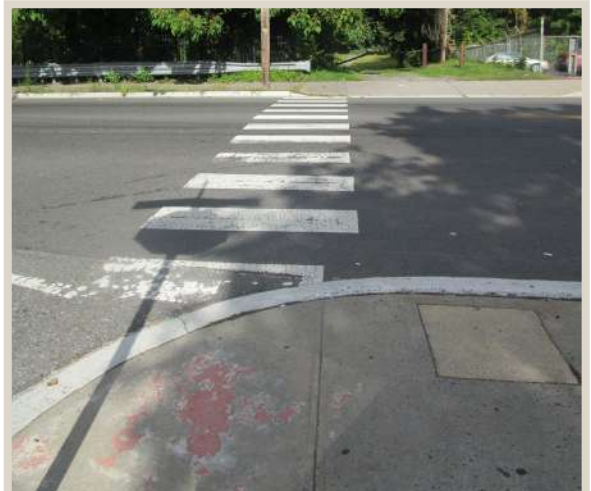
Figure 42. Continental crosswalk with faded ramps.

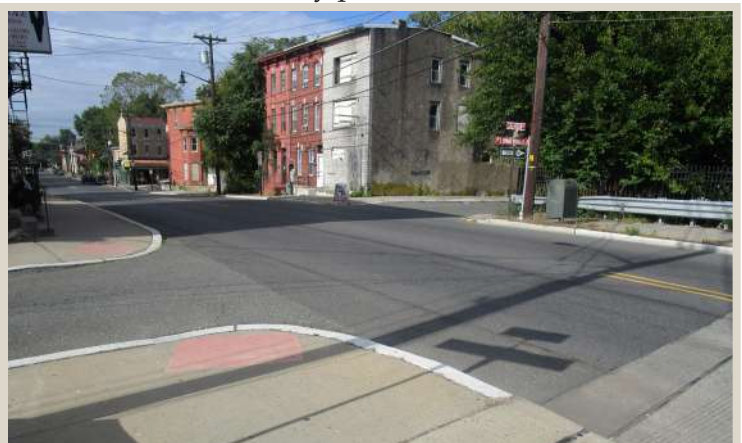
Figure 43. Missing crosswalks and faded ramps at the Church Street intersection.

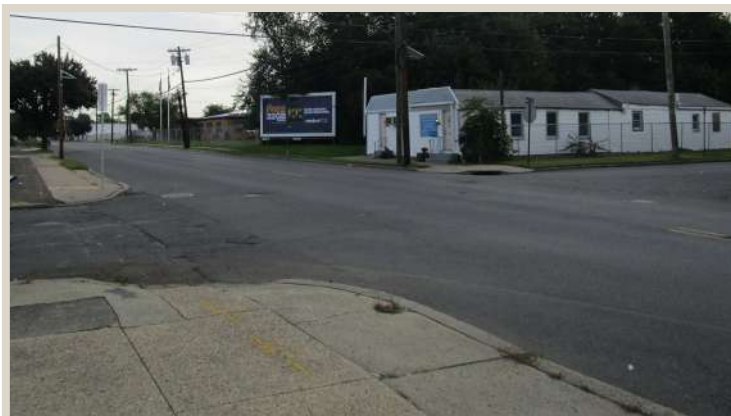
Figure 57. Yellow lines switch with entrance into Trenton.

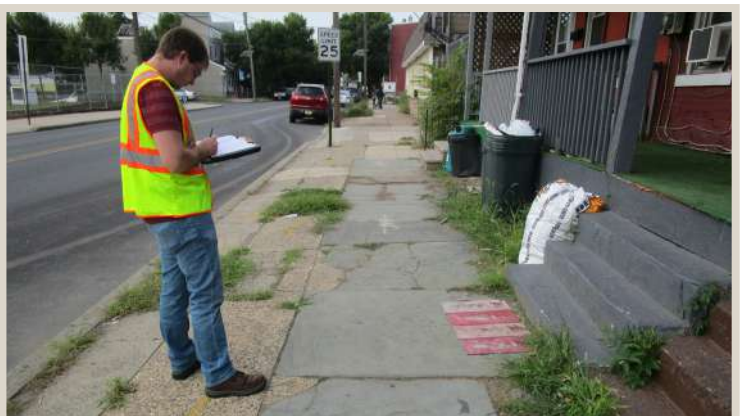
Figure 58. No signage signifying entrance into Trenton.

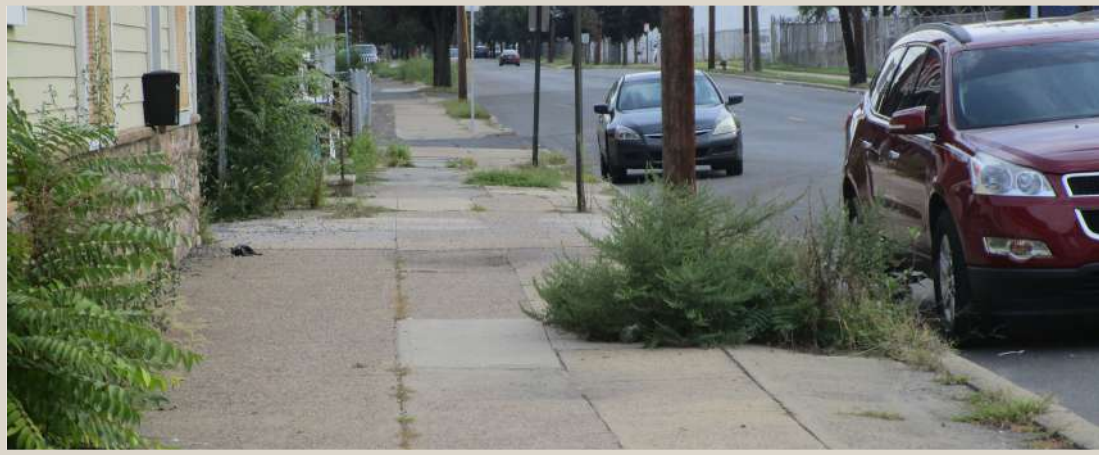
Figure 59. Cracked sidewalks and overgrown weeds.

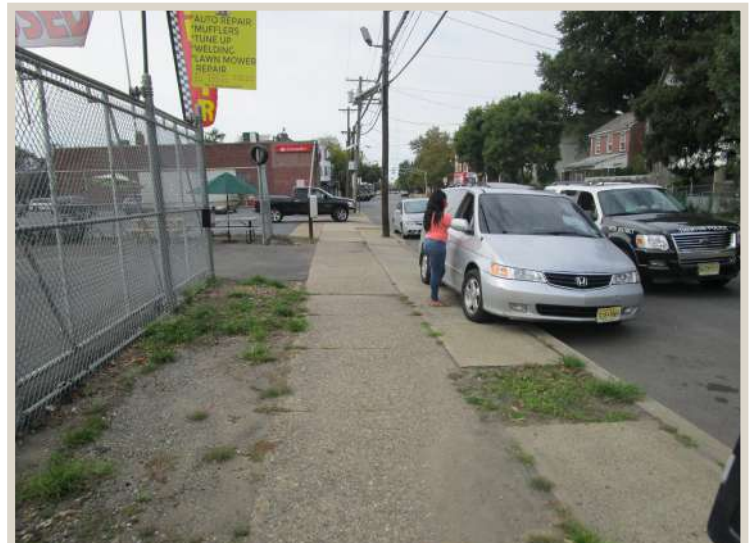
Figure 61. This highly visible sidewalk is not pedestrian friendly.

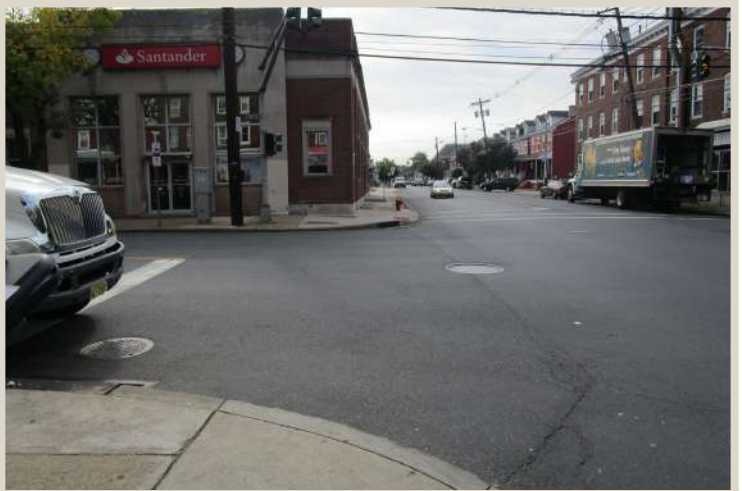
Figure 63. Missing crosswalk at North Olden Avenue intersection.

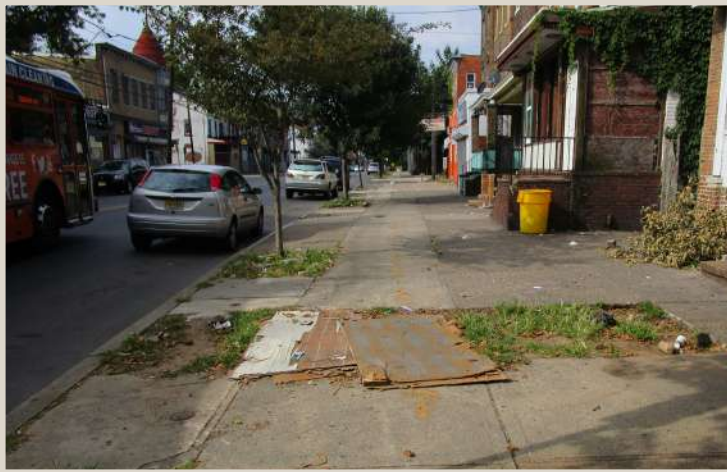
Figure 66. Missing sidewalk with makeshift bridge.

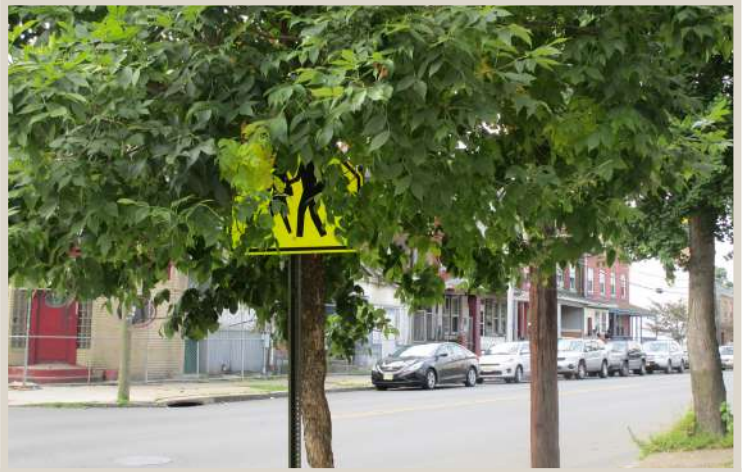
Figure 67. Mid-block crosswalk sign covered by overgrown tree.

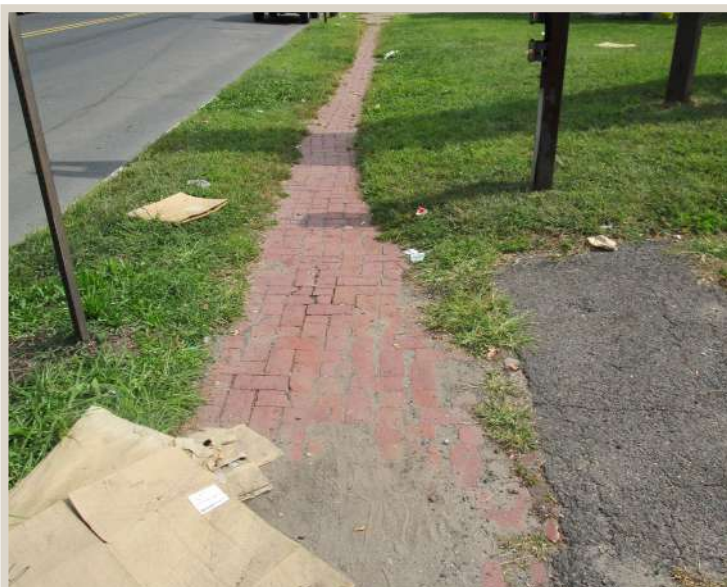
Figure 72. Sidewalk narrows and nearly disappears.

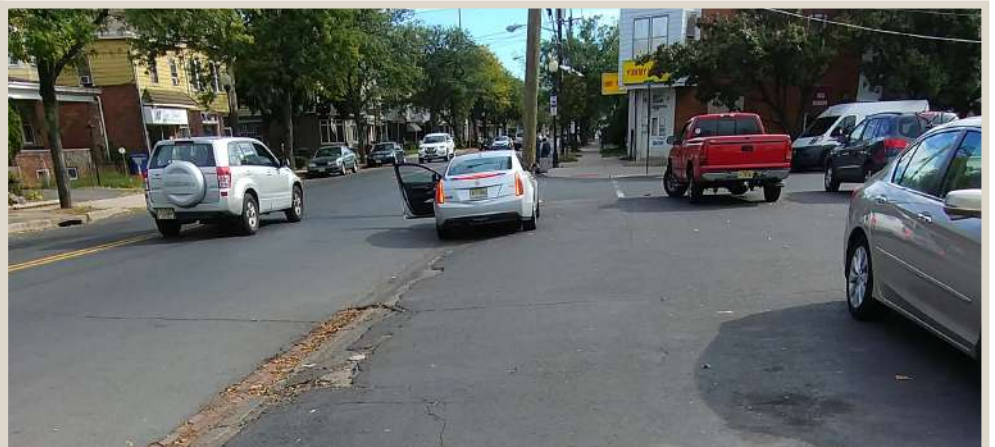
Figure 87. Missing sidewalks along Hamilton Avenue.

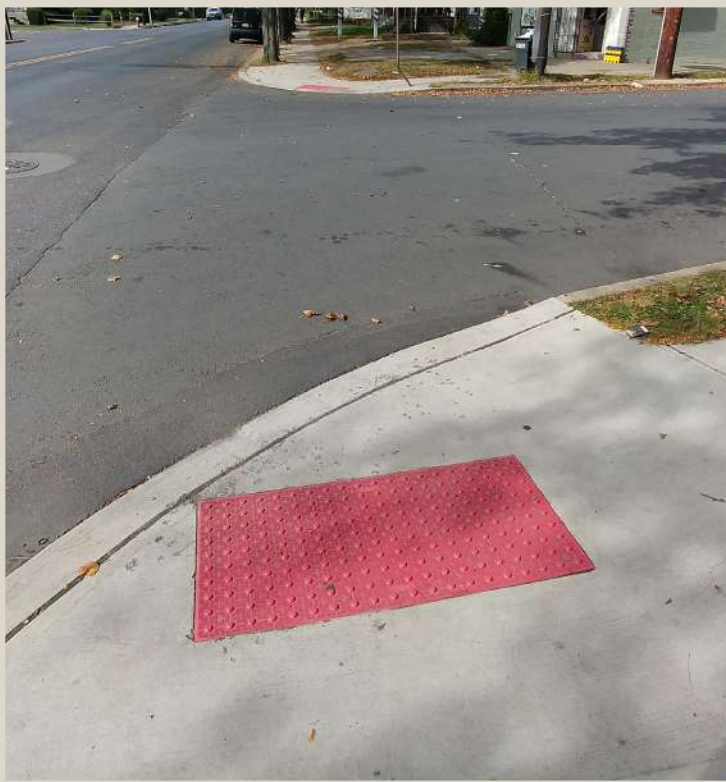
Figure 88. ADA compliant ramps, but missing crosswalks.

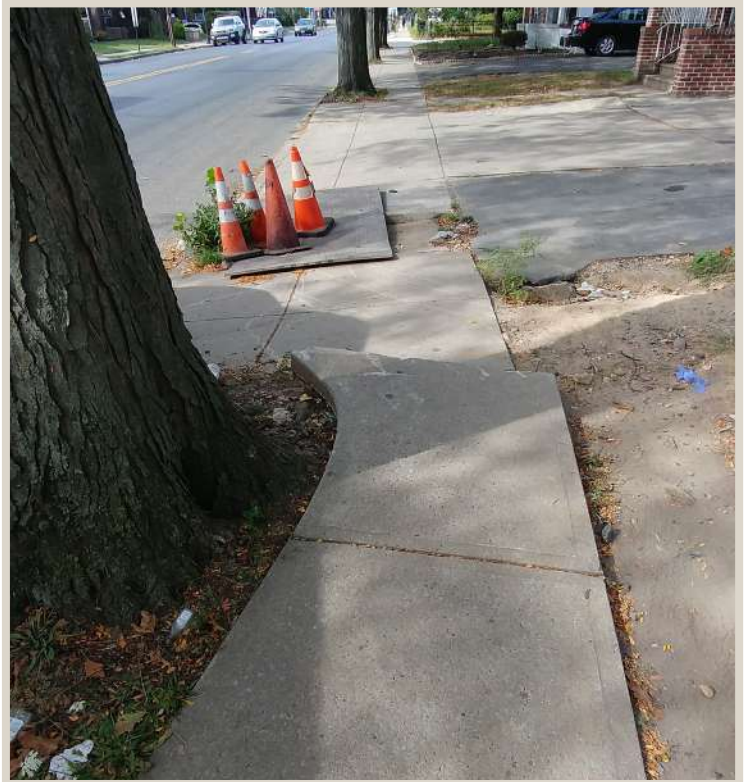
Figure 89. Tree-lifted sidewalk creates a barrier for some pedestrians.

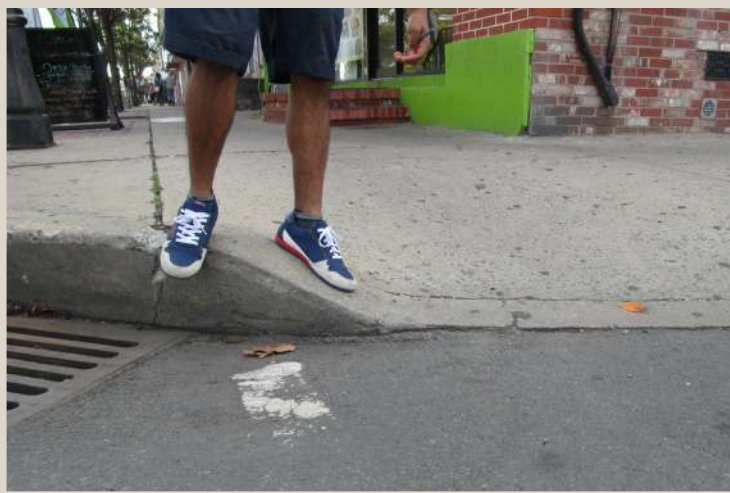
Figure 97. Curb ramp with a steep slope and missing truncated domes.

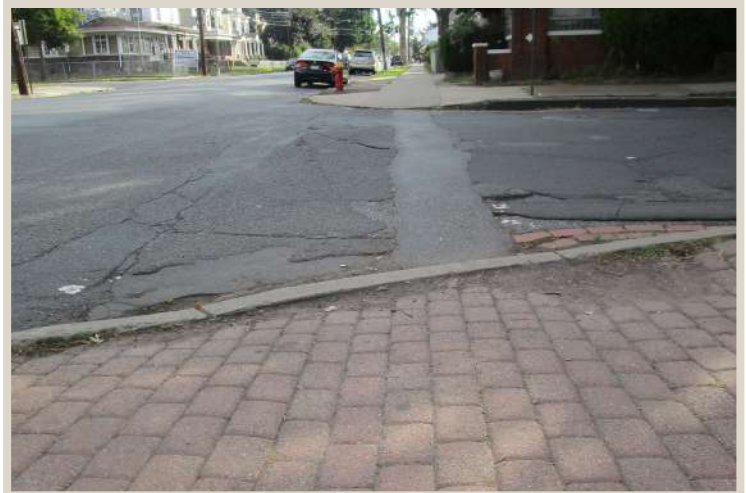
Figure 98. Missing crosswalk and non-compliant curb ramps.

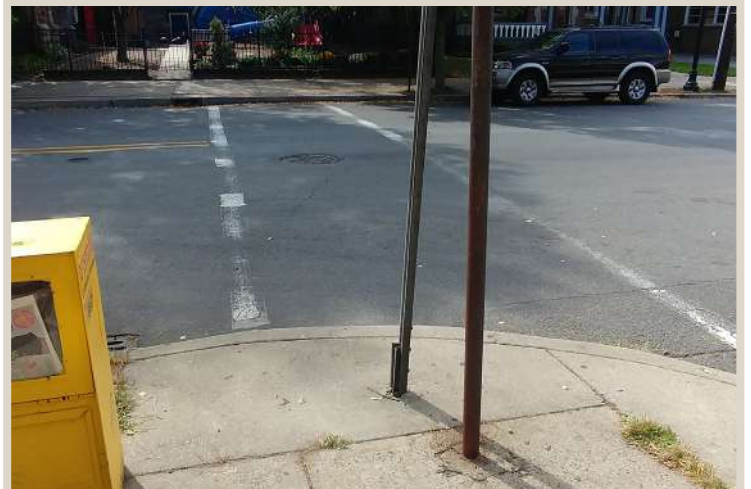
Figure 103. Missing curb ramps.

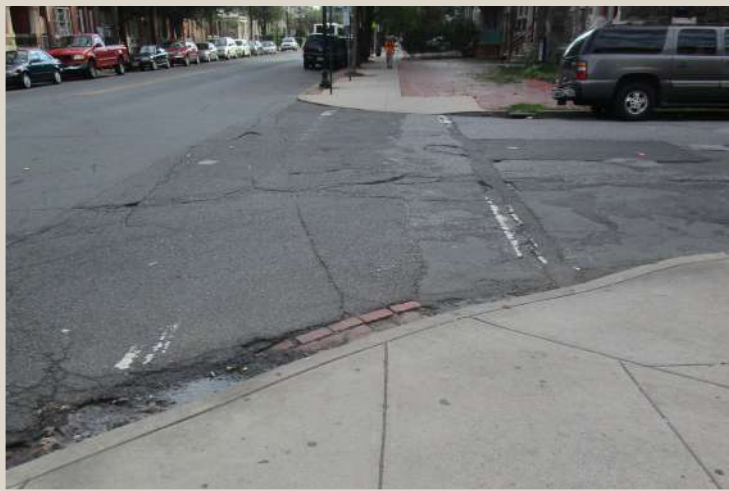
Figure 106. Faded crosswalks and non-compliant ramps.

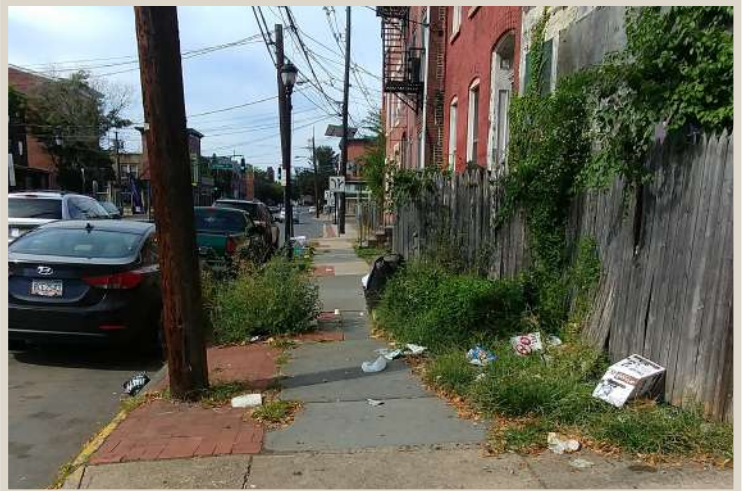
Figure 107. Sidewalk cluttered with litter and overgrown shrubbery.

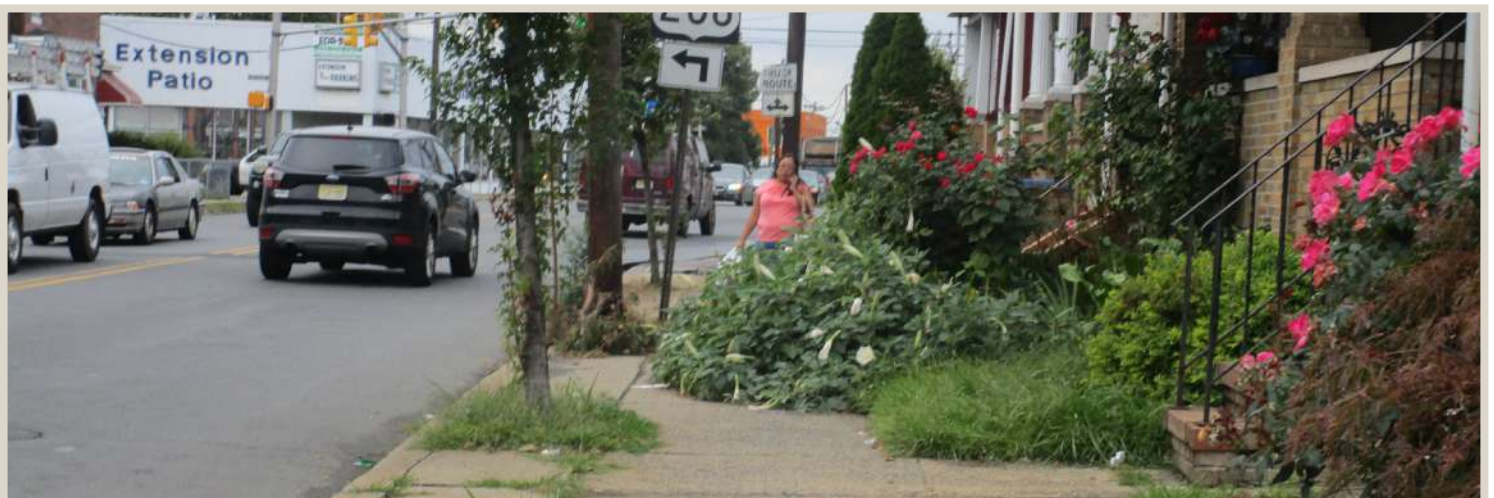
Figure 117. Overgrown plantings block entire sidewalk.

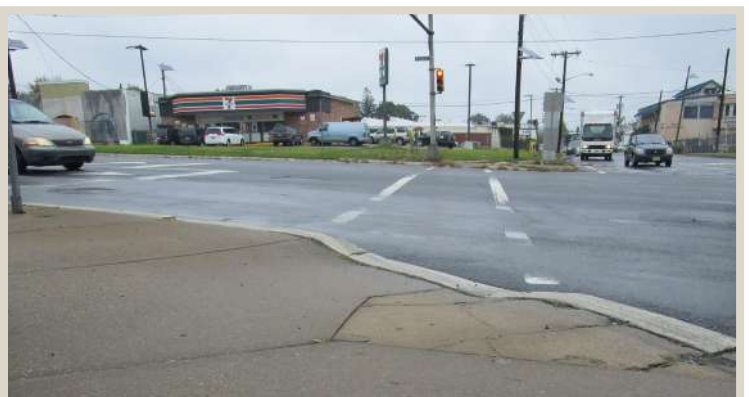
Figure 123. Non-compliant ramps and a turning radius that encourages high speed turns.

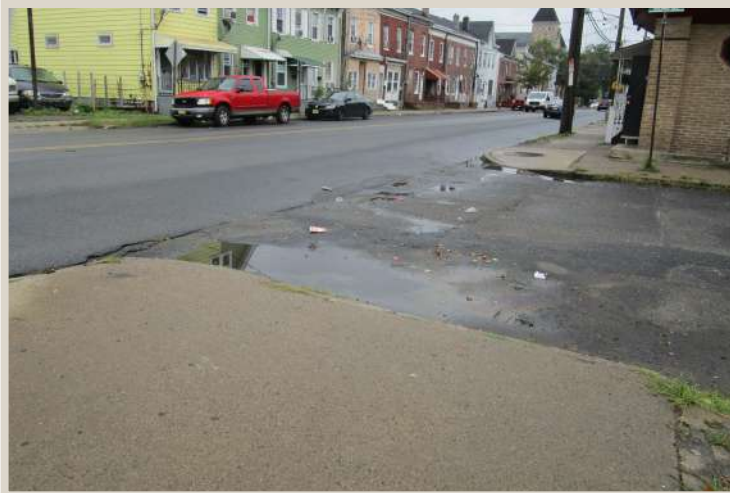
Figure 124. Missing crosswalk and non-compliant ramps.

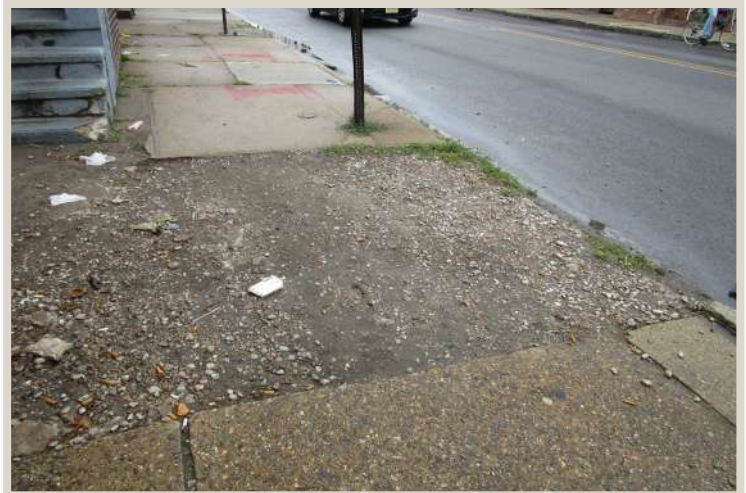
Figure 125. Sidewalk reduced to dirt and gravel.

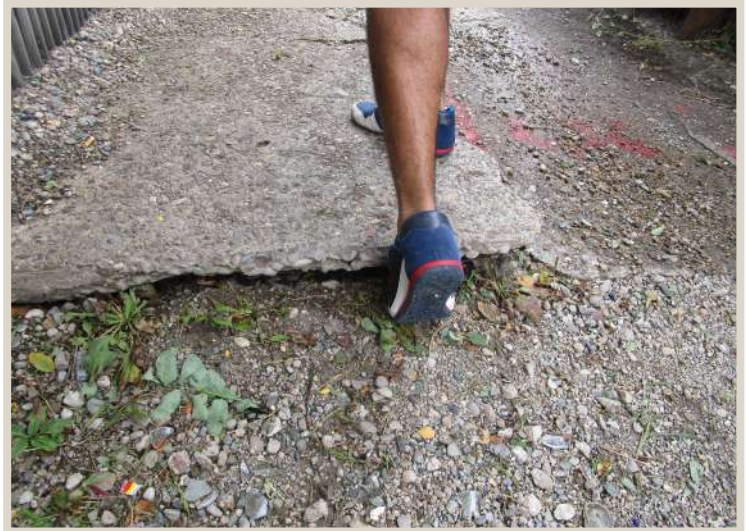
Figure 134. Sidewalks in extremely poor condition.

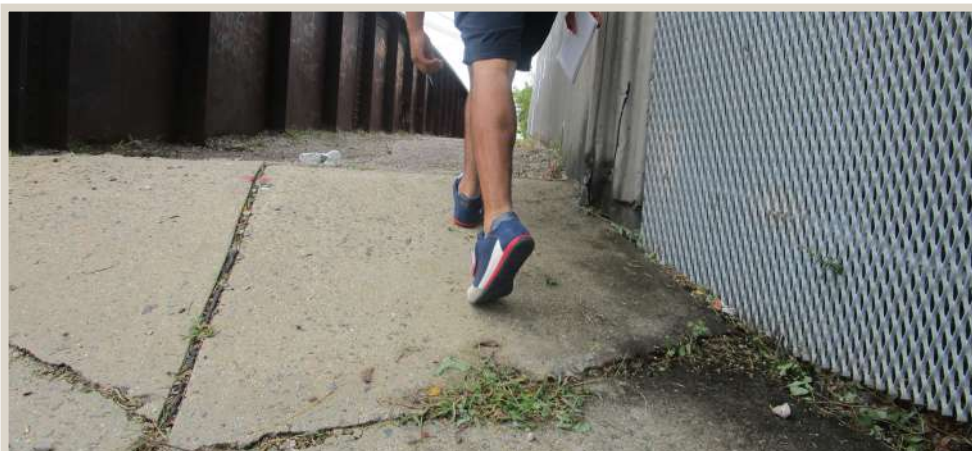
Figure 135. Steep incline along cracked sidewalks.

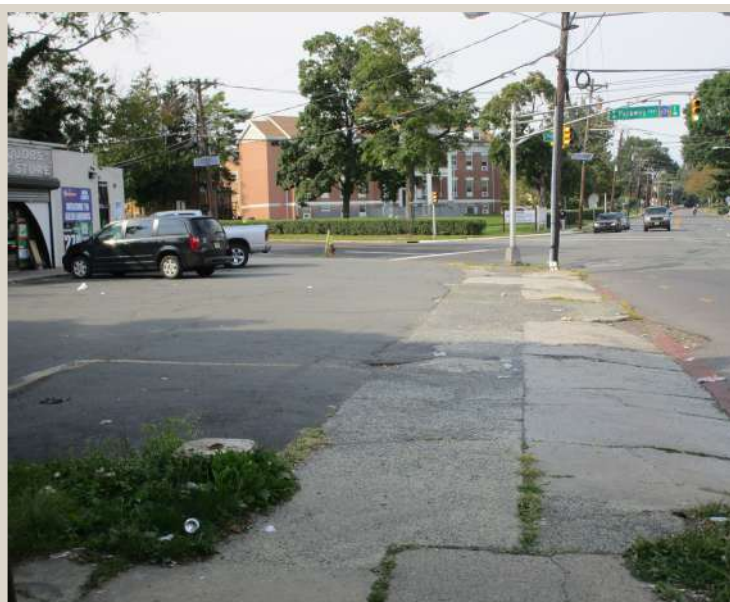
Figure 139. Continuous driveway access across sidewalk.

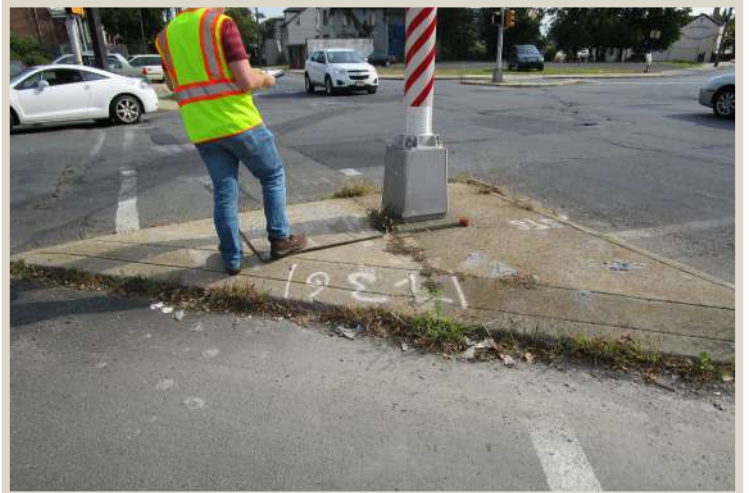
Figure 146. Missing ramps on pedestrian island.

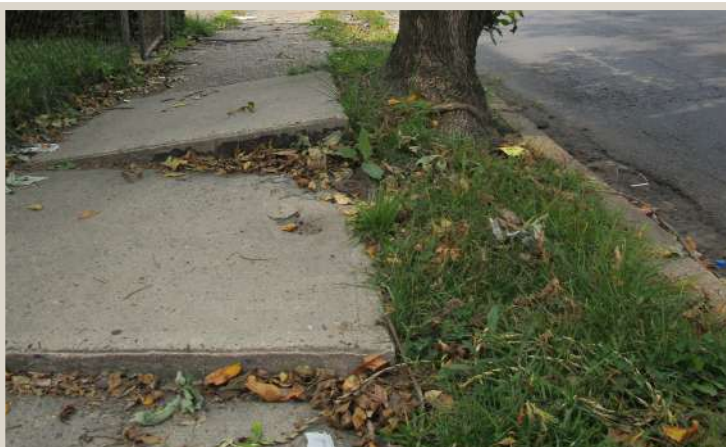
Figure 147. Roots have lifted the sidewalk into stairs.

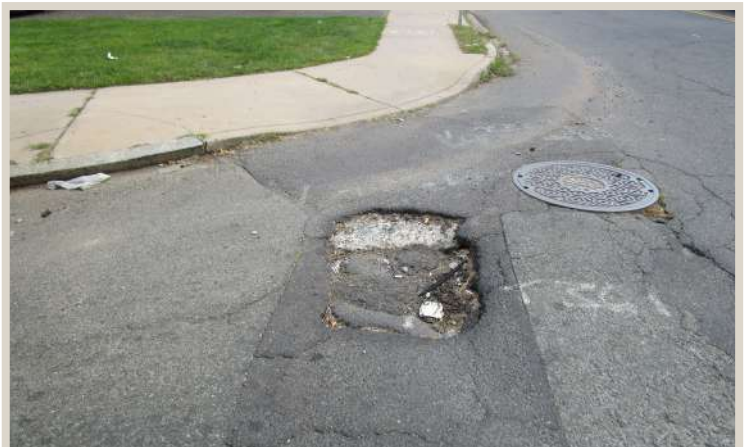
Figure 148. Asphalt near crosswalk in poor condition.

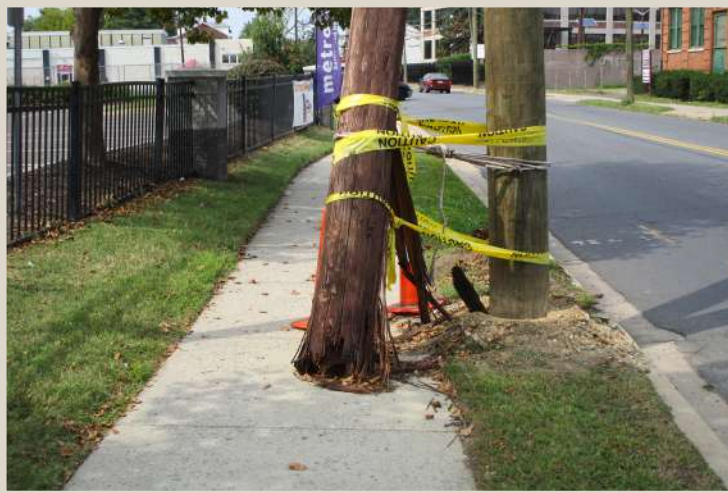
Figure 149. Haphazard utility pole work.

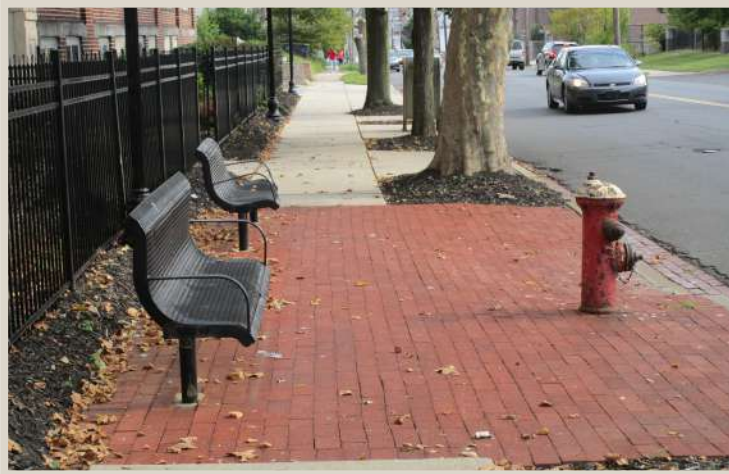
Figure 153. Bus stop amenities located away from the bus stop.

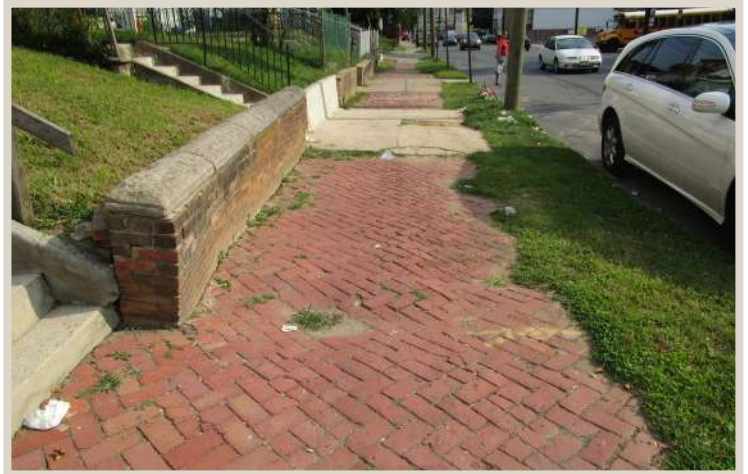
Figure 154. Sidewalk in poor condition.

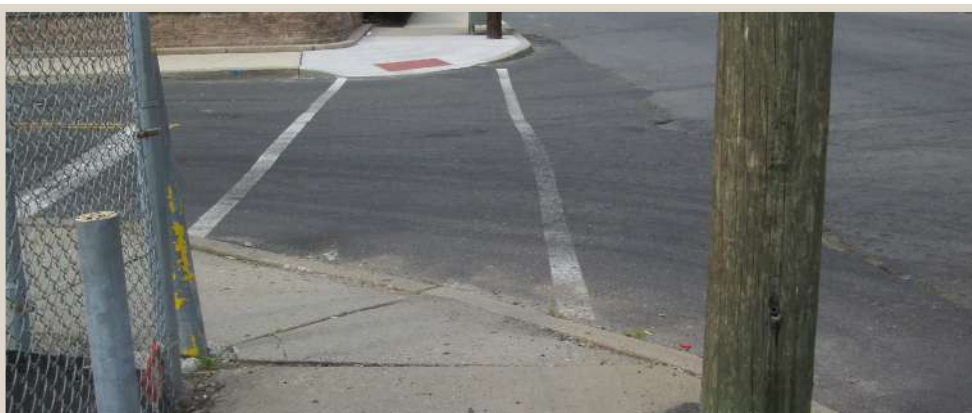
Figure 155. Non-compliant ADA ramp is oriented diagonally into the intersection.

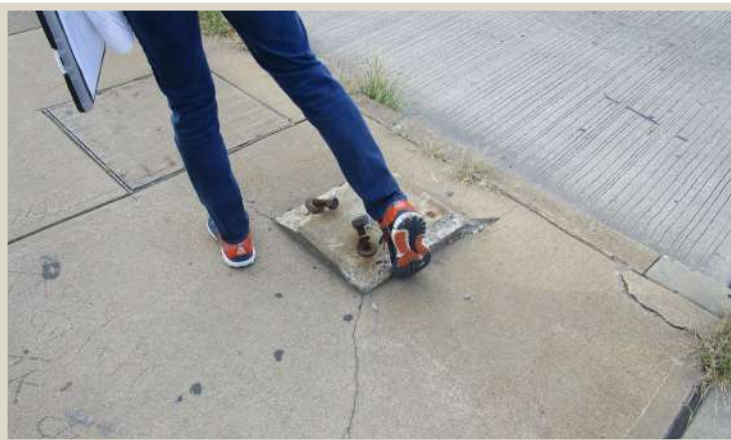
Figure 161. Tripping hazard along the sidewalk.

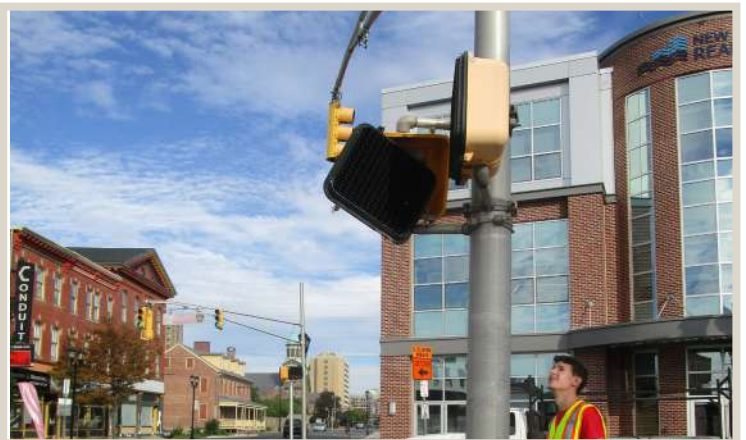
Figure 162. Non-operational pedestrian signal.

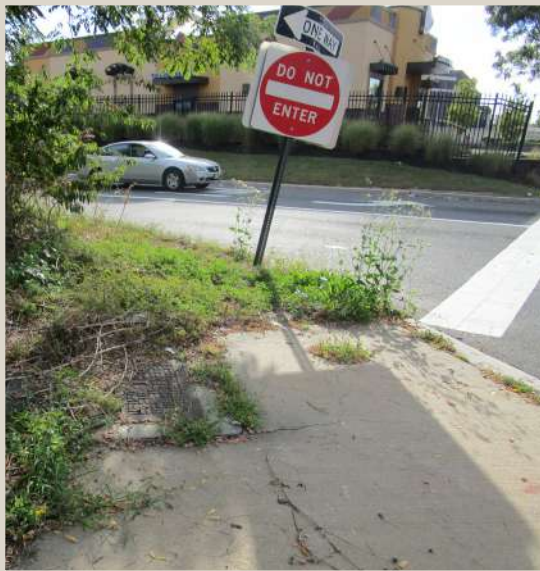
Figure 163. Missing sidewalks.

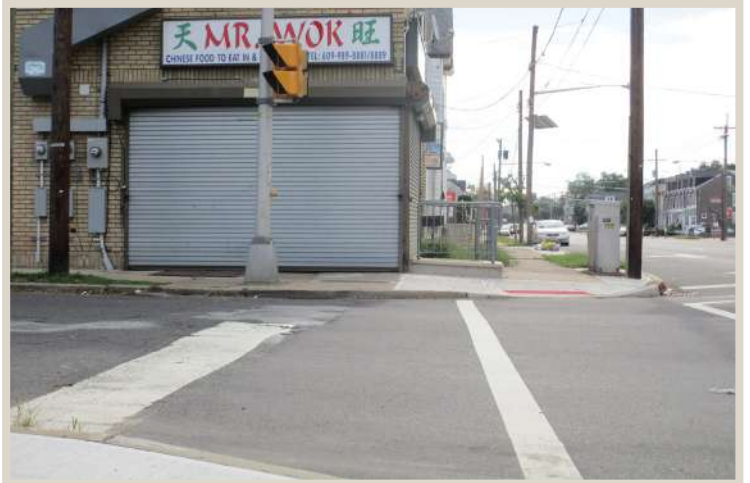
Figure 170. Misaligned pedestrian signal.

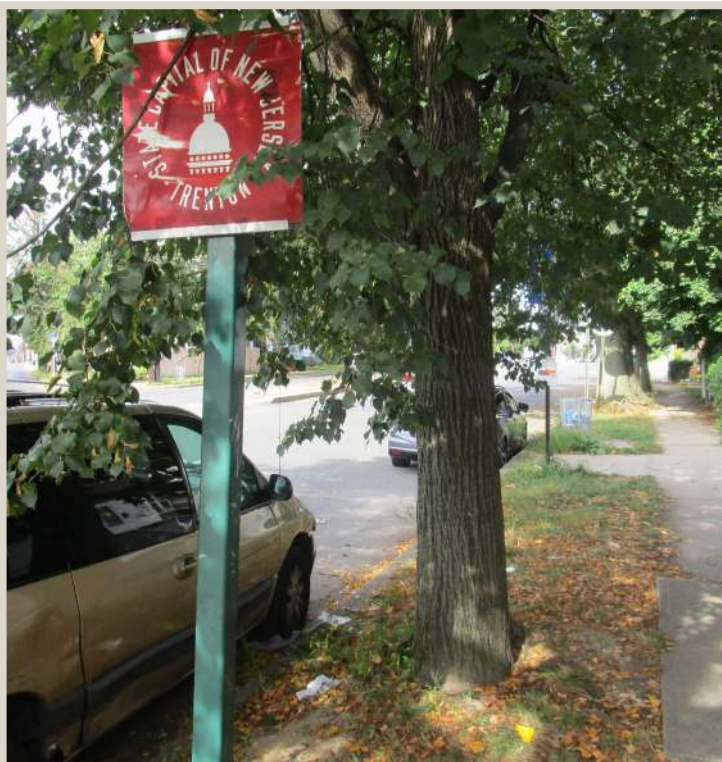
Figure 175. Signage blocked by a tree.

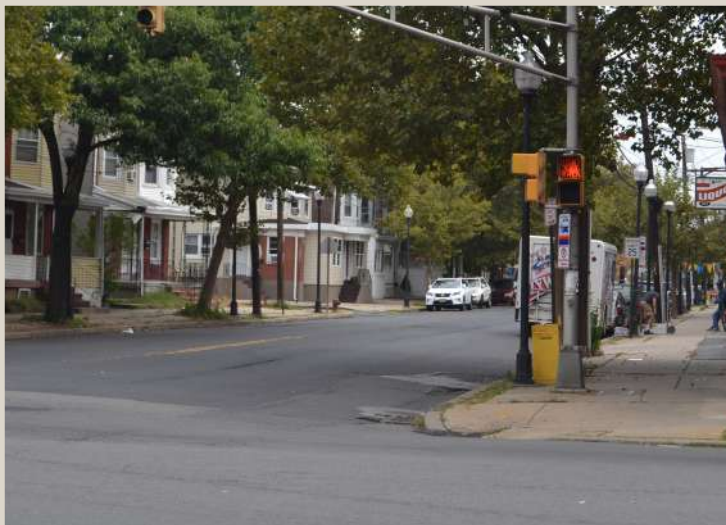
Figure 177. A missing crosswalk at the long intersection of Brunswick Avenue and N Olden.
