Complete Streets in the City of Trenton: Existing Conditions Analysis

May 2018

Prepared for:
The Trenton Health Team

Prepared by:
**The Alan M. Voorhees
Transportation Center**
Edward J. Bloustein School of
Planning and Public Policy
Rutgers, The State
University of
New Jersey

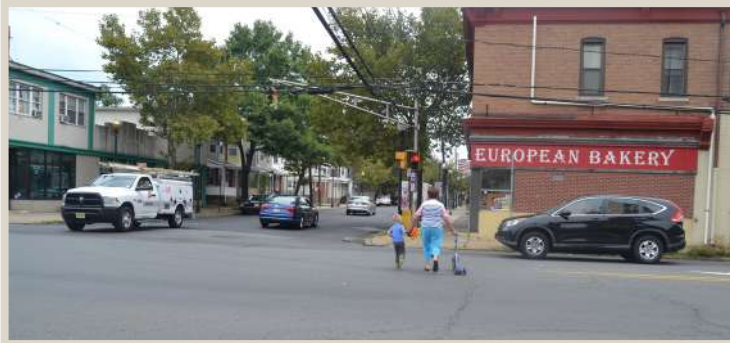
Brunswick Avenue and North Olden Avenue is a major intersection controlled by a traffic light. Although not delineated with multiple lanes, vehicles were observed forming two lanes at the signal. Crosswalks and stop bars are extremely faded (Figure 12). Although curb ramps exist, they do not meet ADA standards. Additionally, the ramps are oriented towards the center of the intersection,

Figure 12. Pedestrians crossing N. Olden Avenue, crosswalk not painted.

rather than into the crosswalks. The pedestrian signal head on the west side is dim, making it hard to see.

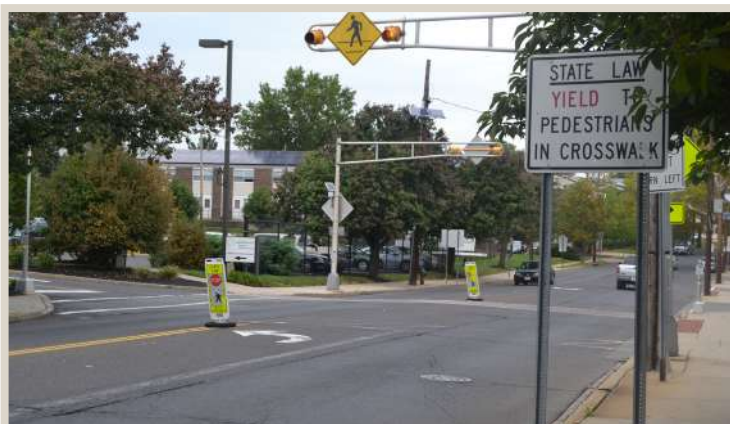
South of the intersection, the sidewalk loses the decorative brick pavers. Instead, the area adjacent to the curb has grass. Additionally, the historic-style street lights do not exist south of this intersection. Approaching the Capital Health Regional Medical Center there is a sign stating "Hospital Zone," a sign noting the 25 mph speed limit, and a sign warning of pedestrian crossings (Figure 14).

Figure 14. Crosswalk and pedestrian crossings signs by Capital Health Regional Medical Center.

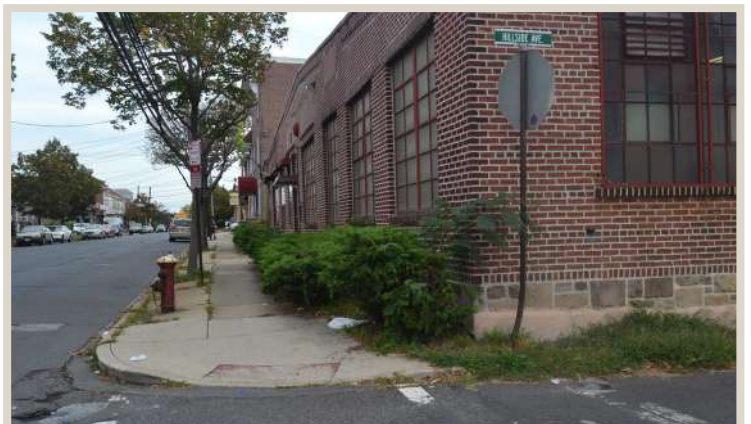
Figure 15. Building at corner of Brunswick and Hillside blocks sight lines for vehicles arriving at the stop sign.

Hillside Avenue is a very minor street which resembles an alley more than an avenue. It terminates at Brunswick Avenue with a stop sign. Due to the presence of a building, there is almost no visibility of the sidewalk and roadway for vehicles arriving at the stop sign (Figure 15).

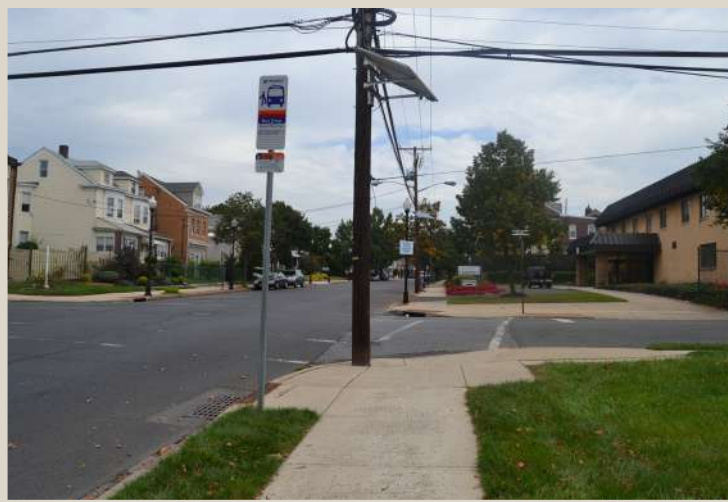
Figure 16. Bus stop with grass strip between sidewalk and curb.

East Paul Avenue and Sylvester Street both terminate at Brunswick Avenue within 50 feet, creating the appearance of a large intersection. Sylvester is one-way westbound, while East Paul is bidirectional. Once again, there are no crosswalks across Brunswick, and faded crosswalks across those secondary streets. There are NJ Transit bus stops just north of the intersection, and both have a strip of grass separating the sidewalk from the curb, creating a challenge for passengers with mobility devices (Figure 16).

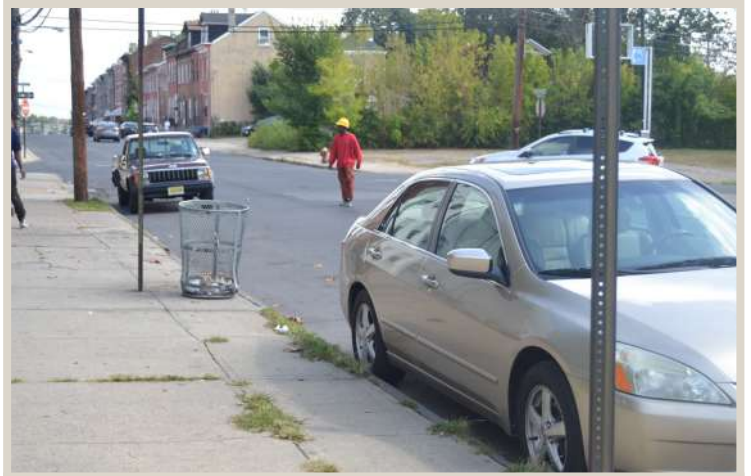
No transit stops are present along this segment of Brunswick Ave. No pedestrian amenities aside from one garbage can are present and there is a high volume of litter around the Sanford Street intersection (Figure 21). Additionally, the eastern section of this segment near the Sanford Street intersection has a high number of vacant properties.

Figure 21. A garbage can, a rare pedestrian amenity, near 217 Brunswick Avenue.

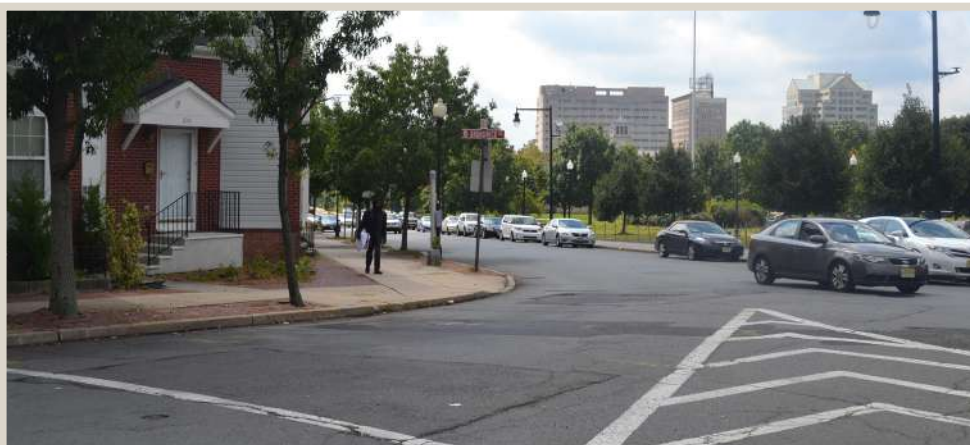
The Brunswick Avenue corridor ends at North Broad Street, adjacent to the Trenton Battle Monument. Drivers entering Brunswick Avenue do so at a curved angle, designed for higher speeds (Figure 22). There is a marked crosswalk across Brunswick Avenue, but none available for pedestrians to reach the monument.

Figure 22. Entrance to Brunswick Avenue corridor.

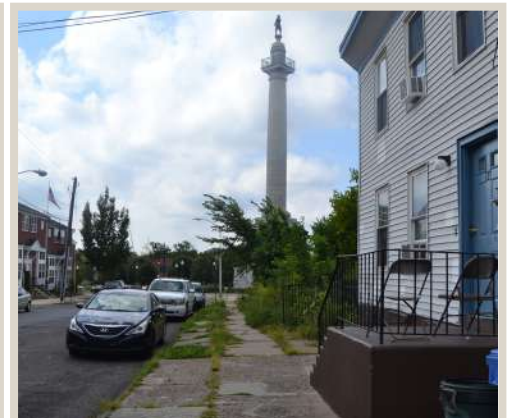
Due to the presence of more recently constructed townhomes, there are additional streetlights along the sidewalk. These streetlights continue on the east side to the end of Brunswick Avenue. Additionally, the east side has a decorative brick sidewalk lining and well-kept street trees. In contrast, the west side is barren with a narrow sidewalk in poor condition (Figure 23).

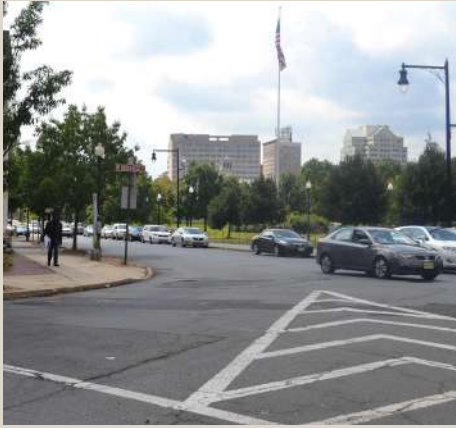
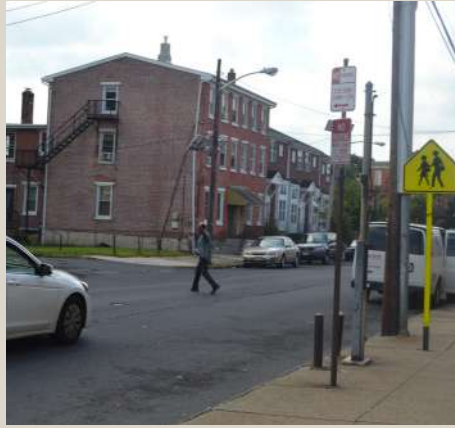
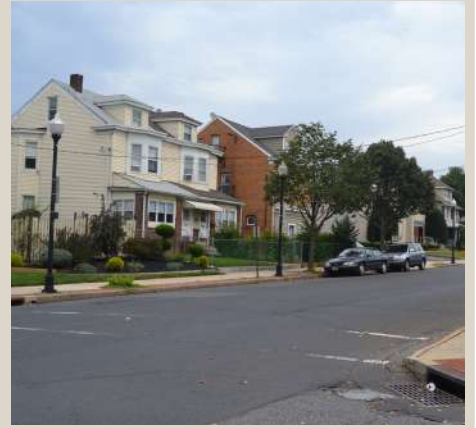
Crosswalks along the entire length of the Brunswick Avenue corridor are either in poor condition or non-existent. A notable exception is in front of the Capital Health Regional Medical Center, where ample signage has been installed. Otherwise, the only painted crosswalks on Brunswick Avenue are located at signalized intersections and are mostly faded.

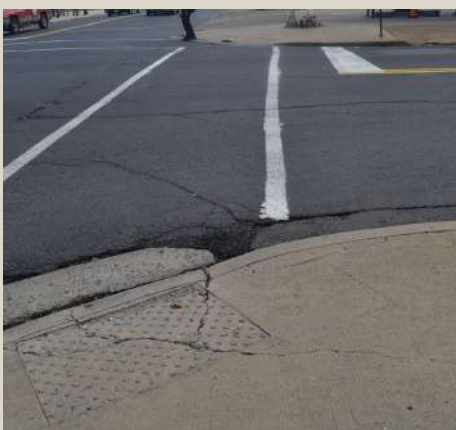
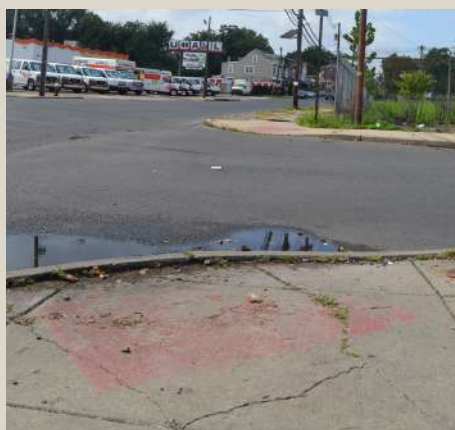
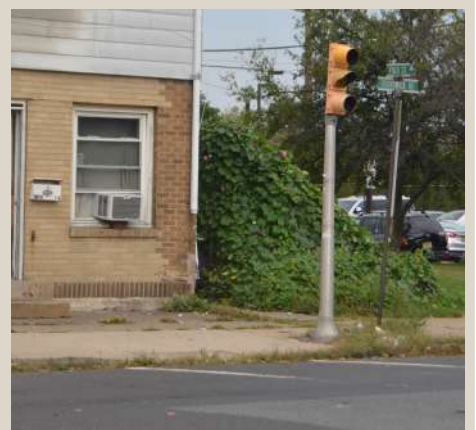
Curb Cuts/Ramps

Brunswick Avenue has many t-intersections, three-way intersections where one road terminates, with minor streets. At these locations, the crosswalks across the secondary street are usually faded, and there is rarely a crosswalk marked to cross Brunswick Avenue. Although most intersections have curb ramps, they are usually in poor condition.

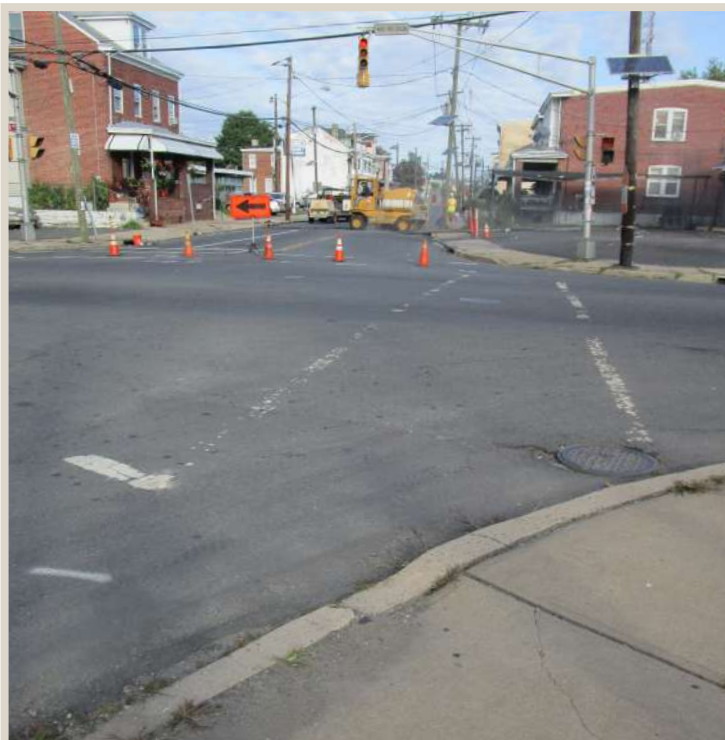
Figure 26. Intersection of Blane Alley and Calhoun Street.

corners feature a single ramp oriented towards the center of the intersection, while the southeast corner has two ramps, each oriented into the crosswalk (Figure 26).

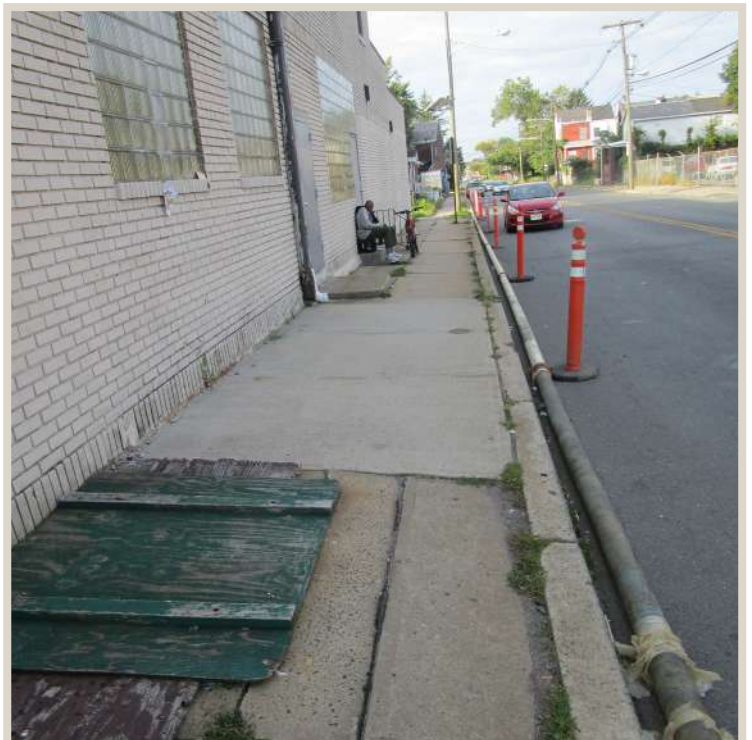
Figure 27. Steps making part of the sidewalk unusable.

South of the intersection, there is a seven-foot sidewalk adjacent to a vacant three-story building, although only half of it is fully usable due to steps leading into the building (Figure 27). Immediately after the building ends, the sidewalk narrows to about four feet with a one-foot planting strip, followed by a section where the sidewalk is immediately adjacent to the curb. The following property is a vacant detached home, and the sidewalk is in very poor condition. There is a driveway which is overgrown. Due to the presence of the corner building, vehicles exiting the driveway have no visibility of oncoming pedestrians.

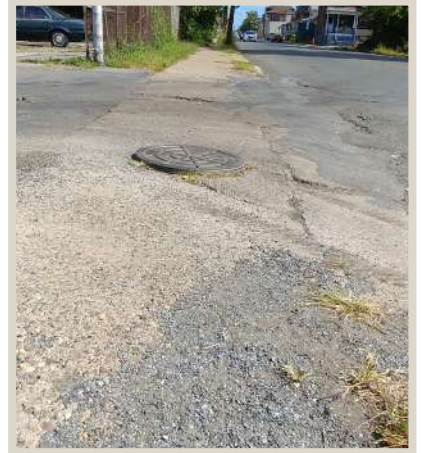
Figure 29. A sloping, uneven sidewalk.

South of Wayne Avenue, the sidewalk is in better condition on the east side. There is some vegetation, but it is generally passable and flat. On the west side, the sidewalk is very narrow and vegetation is overgrown. Additionally, there is some litter. Shortly before reaching New Rose Street, the sidewalk is broken up by frequent driveways. The sidewalk in this area also has many cracks, a slope, and an uneven manhole (Figure 29).

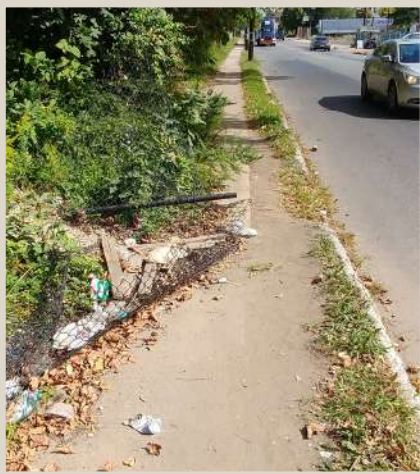
Figure 31. Fallen fence, litter and overgrown vegetation.

The west side sidewalk is in especially poor condition, with a fallen fence blocking most of the walkway. There is also a large amount of litter and vegetation (Figure 31).

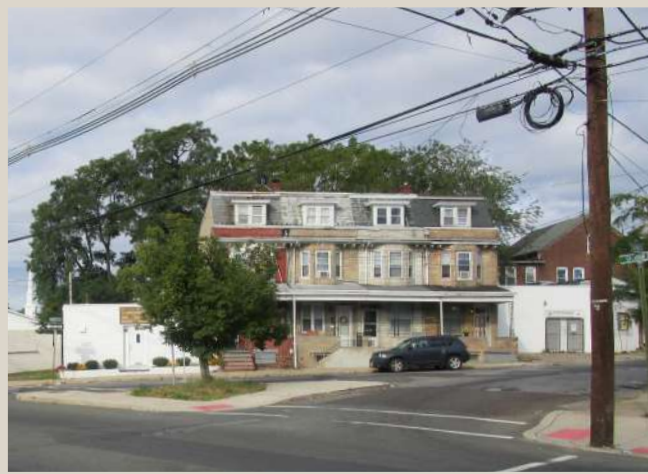
Figure 32. Island diverting traffic from Humboldt Street, a one-way street that runs in the opposite direction.

traffic island, which was fully upgraded. Additionally, two crosswalks exist to cross Calhoun Street (Figure 32).

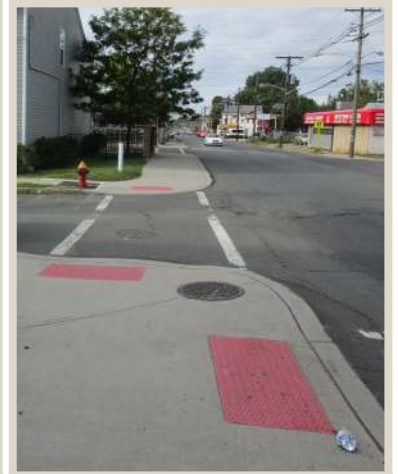
Figure 33. Recently updated truncated domes.

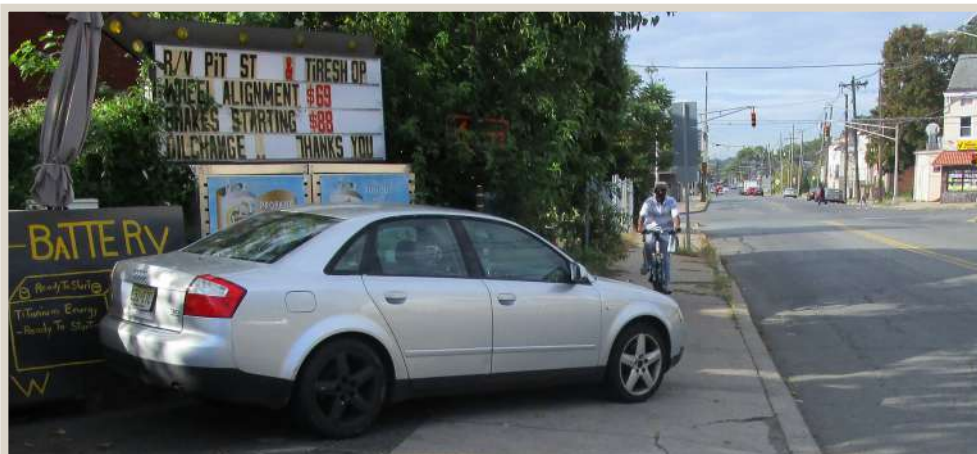
However, south of the intersection, sidewalks return to poor condition. An automotive business on the east side was observed blocking the sidewalk with their parked vehicles (Figure 34), a behavior that is likely frequent, as it was also confirmed using aerial imagery.

Figure 34. Parked car blocking sidewalk along Calhoun Street.

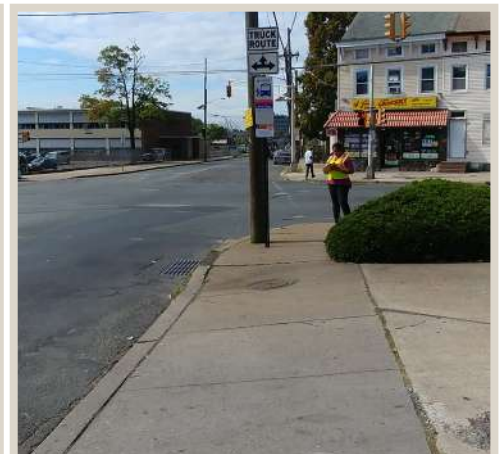
This section of the corridor does not have any amenities such as benches, bicycle racks, or trash cans. There is also no pedestrian oriented lighting, only overhead cobra lights. There is a southbound NJ Transit bus stop on the west side of Calhoun Street, just north of Pennington Avenue, adjacent to a gas station. The sign is at the corner, and any bus stopping there would discharge onto the gas station driveway. However, there is a sidewalk in good condition prior to the driveway where bus drivers could stop instead (Figure 35).

Figure 35. NJ Transit bus stop located at entrance to gas station.

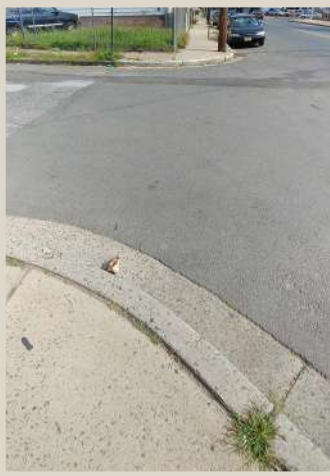
Figure 36. No ramps or crosswalks.

Wilson Street sits on the west side of Calhoun Street, running in one direction to the west. The sidewalks adjacent to this corner are in poor condition due to various vacant rowhomes. The corners lack ramps and there are no crosswalks painted in any direction (Figure 36).

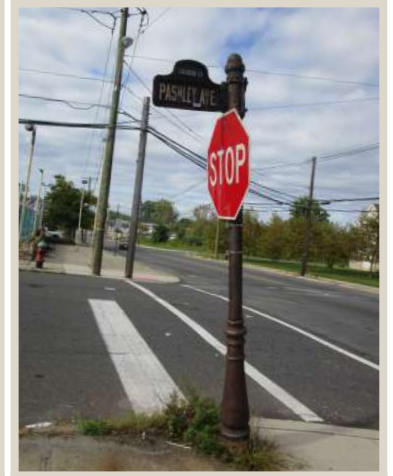
Figure 38. Intersection of Pashley Avenue and Calhoun Street.

Just south of Dunham Street, Calhoun Street intersects with Pashley Avenue, which meets Calhoun St. from the east (Figure 38). The corner ramps appear to be recently installed with a proper slope and truncated domes. However, they are oriented only across Pashley Avenue. There is a marked crosswalk across Calhoun Street on the southern leg of this intersection, but there is no ramp on the west side of Calhoun Street.

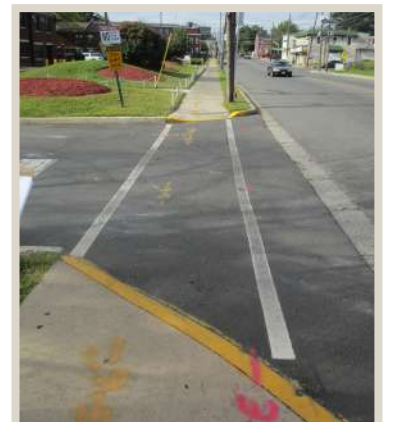
Fairway Drive is another privately maintained roadway that terminates at Calhoun Street, but it is narrower than the previous streets. There is a faded crosswalk and ramps, although they are not ADA compliant (Figure 39). There are NJ Transit bus stops on

Figure 39. Non-compliant ramps.

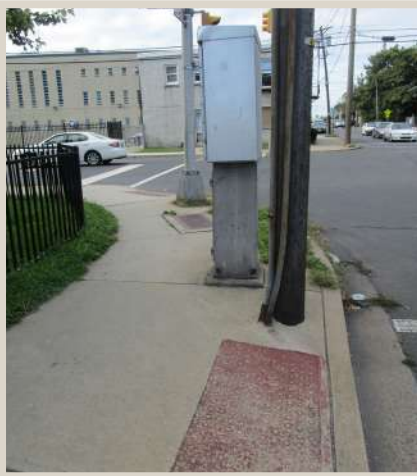
Figure 40. Electronic cabinet blocking pedestrians from drivers' sight.

Bellevue Avenue intersects with Calhoun Street at an intersection controlled by a traffic signal. There are no dedicated turn phases, and there are no pedestrian signals. All four corners have two ramps oriented into the crosswalks, which are painted but badly faded. The northwest corner has a wide turning radius, which may invite speeding. The northeast corner has an electronic cabinet next to the sidewalk ramp which blocks the view of pedestrians from turning vehicles (Figure 40). The same corner has a payphone, but it is not in working order (Figure 41).

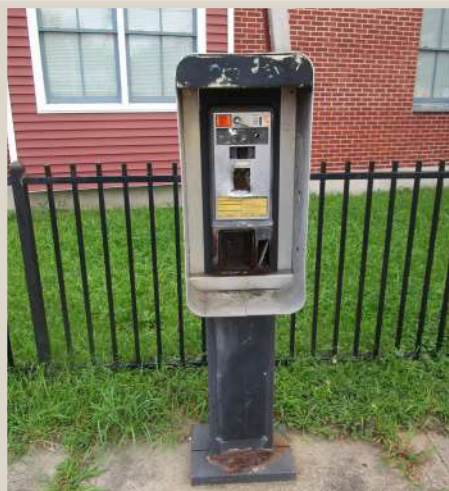
Figure 41. Dilapidated payphone.

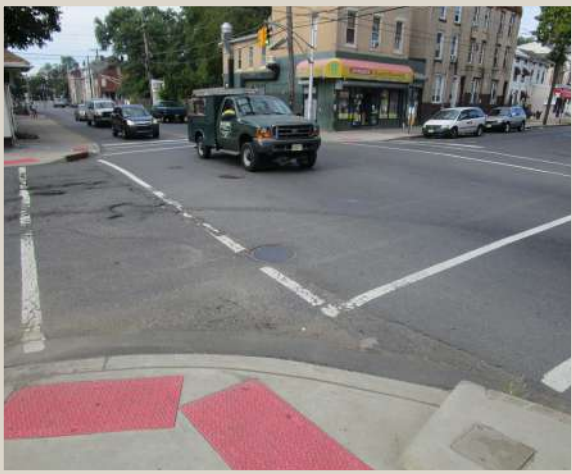
Figure 44. Updated ADA curb ramps, but missing pedestrian signals at Spring Street.

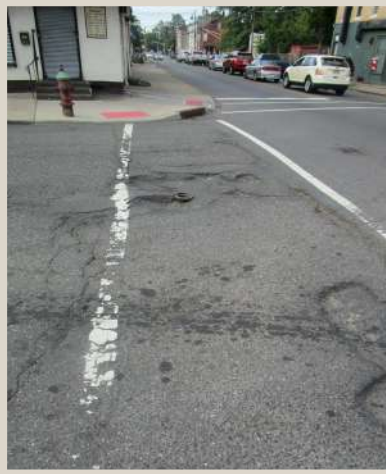
Figure 45. Uneven asphalt.

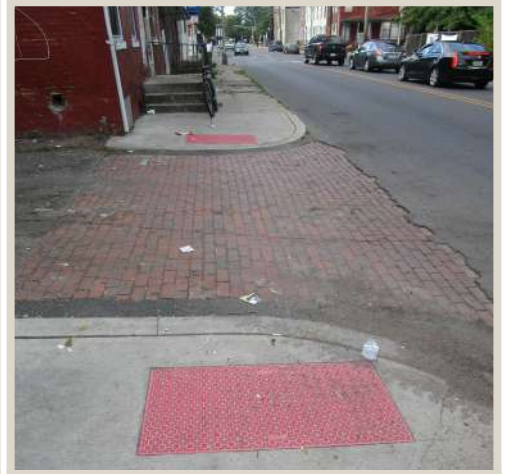
Figure 46. Small brick alley may create challenges for wheeled mobility devices.

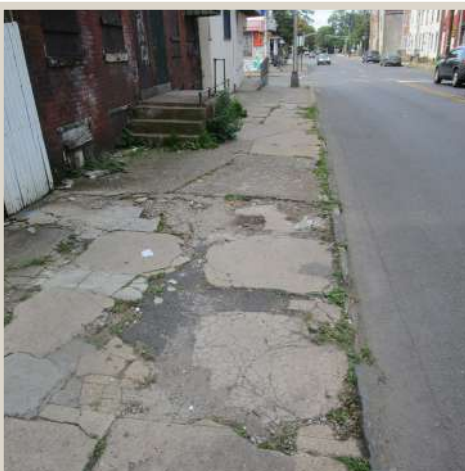
Figure 47. Significantly deteriorated sidewalk conditions.

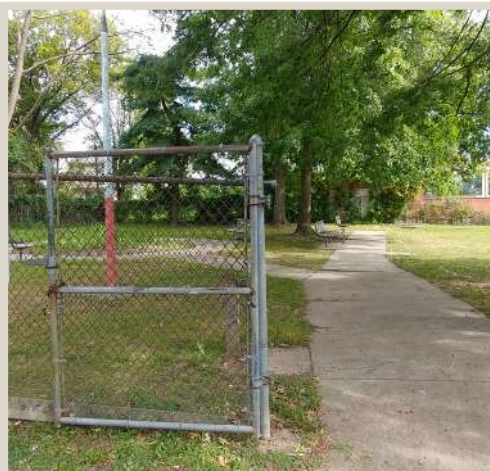
The intersection of Calhoun Street and Passaic Street is controlled with a traffic signal that lacks pedestrian signals. There are four painted crosswalks that are extremely faded, with the west crosswalk being barely visible. Each corner has a single ramp facing into the intersection, but none are ADA compliant. Only the southeast corner has a functioning business, a liquor store. The northeast corner has a closed market, while the southwest corner has a series of damaged buildings. The northwest corner has a park that is in active use, but does not look welcoming due to the chain-link fencing (Figure 48).

Figure 48. Uninviting park entrance.

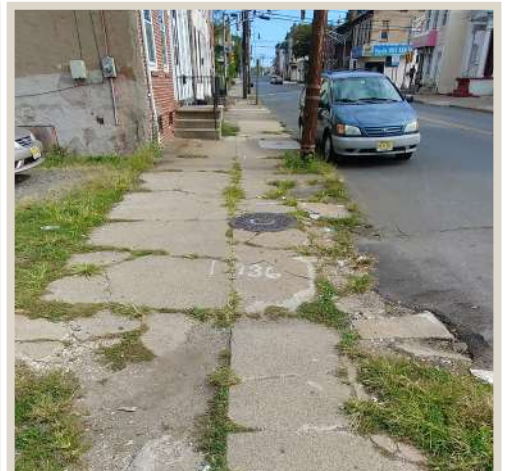
Moving south from the Passaic Street intersection, the eastern side of Calhoun Street is in better condition than the western side. While litter was observed on both sides, the sidewalk in front of the vacant buildings on the west side is broken, with vegetation growing between the cracks (Figure 49). This poor condition is further compounded by a driveway, which results in the entire sidewalk being sloped. Google Maps notes an NJ Transit bus stop on the east side of the street, but there is no signage indicating this at that location. Although the

Figure 49. Vegetation growing along large cracks in the sidewalk.

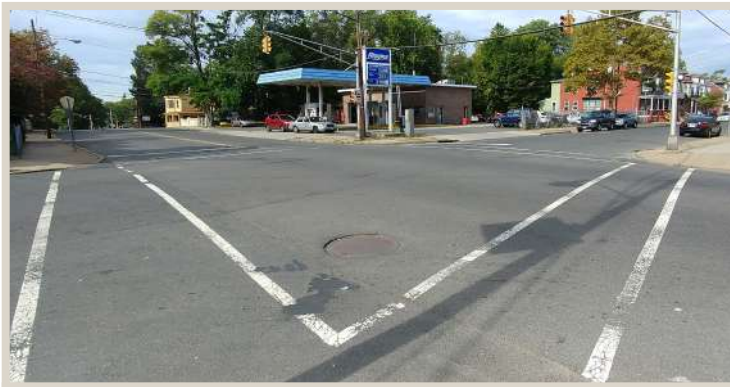
Figure 50. Intersection lacks pedestrian signals and ADA ramps.

Calhoun Street intersects with Hanover Street at a signalized intersection lacking pedestrian signals and ADA-compliant curb ramps (Figure 50). There are four painted crosswalks in decent condition. The intersection feels especially wide, as two corners contain gas stations, and a third is a parking lot. The fourth corner contains an attractive but boarded up three-story building.

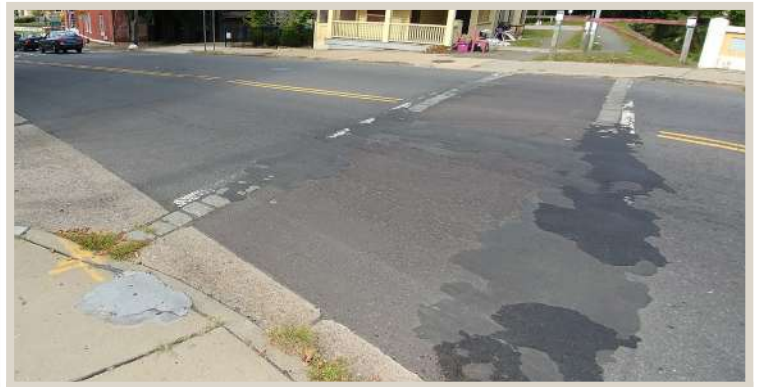
Figure 51. Asphalt-covered pavers along crosswalk.

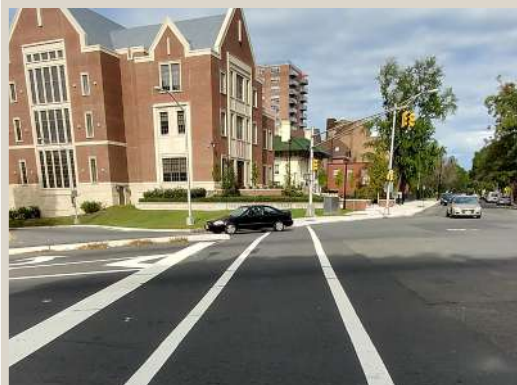
The intersection is controlled by traffic signals, all of which have modern pedestrian signals. There are also standard crosswalks painted in all directions, with the paint on the southern leg being in especially good shape (Figure 53), and the western leg having faded striping. However, very wide turning radii and many lanes make for lengthy crossings for pedestrians, with the southern crossing being over 100-feet long. Additionally, there is no crosswalk painted across the entrance to the NJ-29 on-ramp. Due to the presence of the Mercer County Clerk office tower on the northeast corner and Thomas Edison State University on the southwest corner, this intersection probably sees the most pedestrians of any along the corridor. However, this intersection appears to have been designed as an extension of the highway, and so is the most hostile to pedestrians along the corridor.

Figure 53. Well-maintained crosswalk.

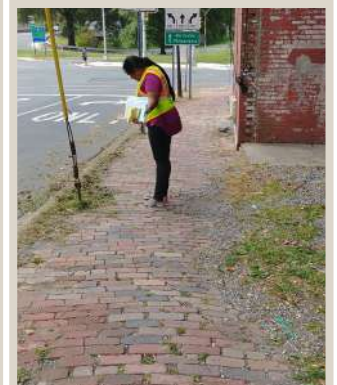
The sidewalk on the northwest corner is unique as it is paved with brick (Figure 54). Although the brick is attractive and historical, it poses a hazard to pedestrians, especially those in wheelchairs. The other corners feature newer sidewalks with ramps, although only the ramps on the southwest corner are fully compliant. There are two bus stops on West State Street on the east corners of the intersection. These bus stops include shelters for waiting riders. There are multiple cobra-style lights pointed towards this intersection, but due to the width, the lighting may not be adequate.

Figure 54. Brick sidewalk.

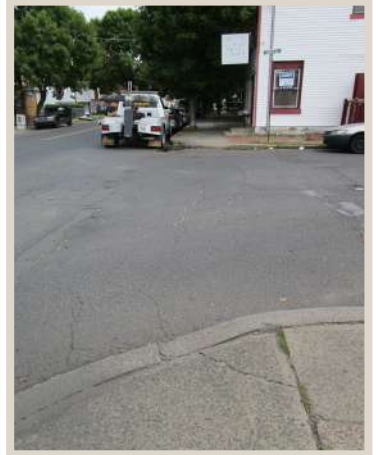
Figure 60. Missing curb ramps.

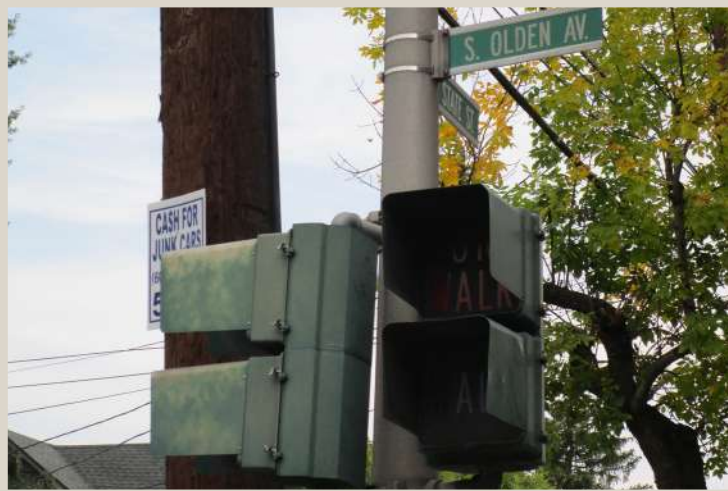
Figure 62. Dim and outdated pedestrian crossing signals.

The intersection of East State Street and North Olden Avenue is controlled by a traffic signal. There are no left turn lanes or signals in any direction. There are automated (no button) crosswalk signals in the older ‘Walk/Don’t Walk’ style, but they are dim and difficult to read (Figure 62). Although the signals face all four directions, there are only painted crosswalks and ramps for three of the four legs. The northern leg is missing a crosswalk (Figure 63).

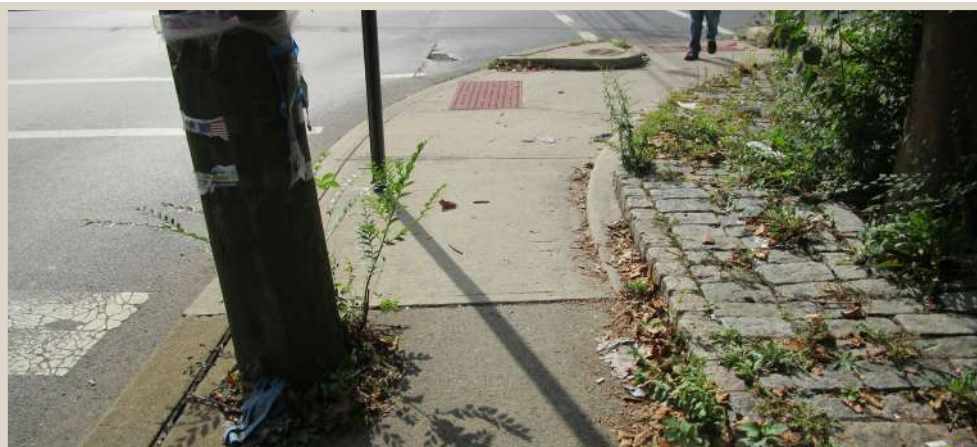
The southwest corner has two ramps that are oriented and installed correctly. However, immediately after the ramp, the sidewalk on North Olden Avenue narrows to just twelve inches due to a utility pole, making it non-compliant (Figure 64). The northwest corner has a single ramp, which feeds into a very narrow sidewalk. The design of the corner may make navigation in a wheelchair very difficult (Figure 65).

Figure 64. Utility pole drastically minimizes available walking space for pedestrians.

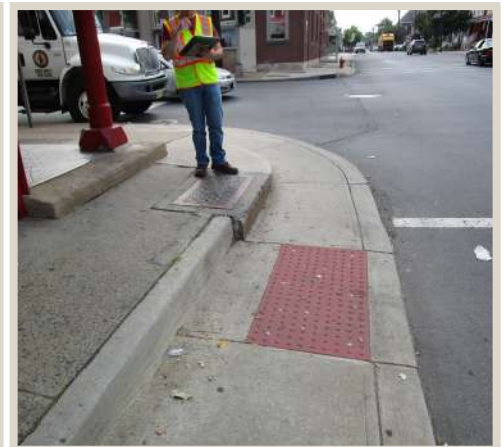
Figure 65. Challenging curb design.

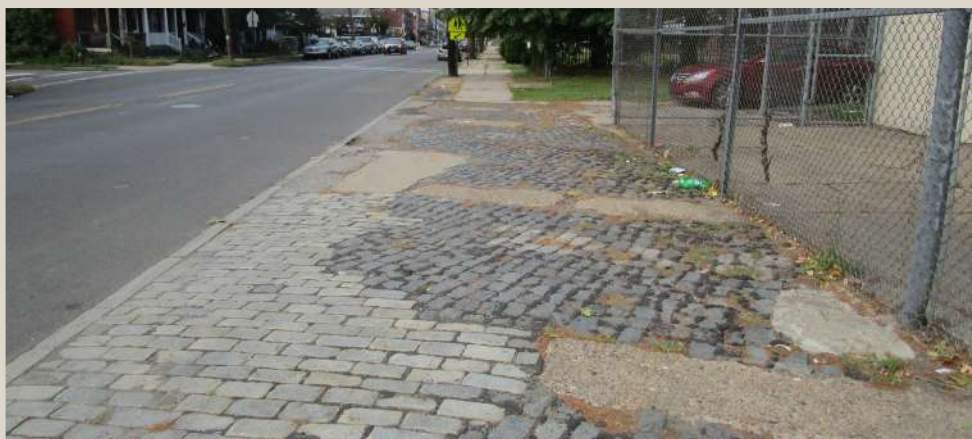
quality varies, with the worst conditions being in front of vacant properties. On the west side, the sidewalk in front of Hutchinson Industries becomes a very long sidewalk paved with bricks. The inconsistent layout of the brickwork may make it difficult to traverse this area in a wheelchair (Figure 68).

Figure 68. Uneven brickwork along East State Street.

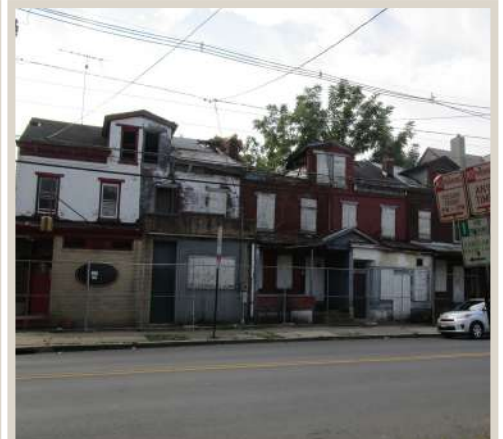
This block has a large cluster of vacant homes, which make the segment feel more isolated than the previous ones (Figure 69).

Figure 69. Abandoned homes.

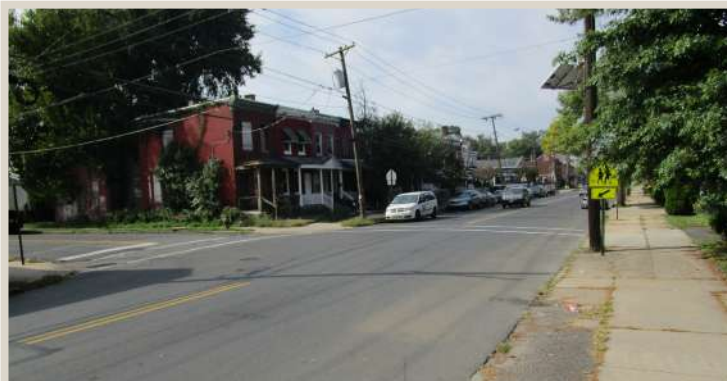
Figure 70. Visible crosswalk signage along East State Street.

a single crosswalk painted to cross East State Street on the southern leg of the intersection (Figure 70). There is crosswalk signage visible in both directions and each of the crosswalks has a ramp with truncated domes. However, the domes are very faded and barely visible. There is an overhead light at the intersection.

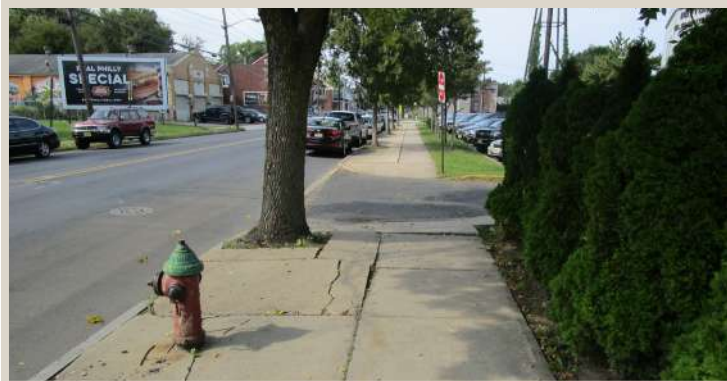
South of Cuyler Avenue, the sidewalk is in better condition on the west side along P.J. Hill Elementary School. The school is set back behind a large lawn and the sidewalk is separated from the campus with a fence and landscaping. The sidewalk is interrupted by a driveway to a small parking area and the curb ramps to cross the driveway are lacking truncated domes. Additionally, the sidewalk immediately before the driveway has been lifted by a tree. Vegetation blocks view of the sidewalk for motorists exiting the parking area (Figure 71).

Figure 71. Shrubbery blocking driver's visibility of sidewalk.

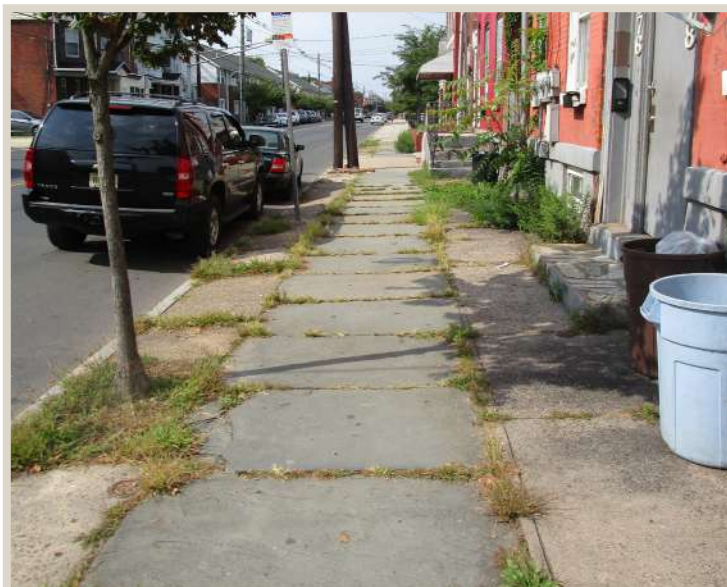
South of Cook Avenue, on the west side of East State Street, there are four residential properties and a small church. The sidewalk is in poor condition due to vegetation growing in the large gaps between the concrete sidewalk panels (Figure 73). Past these properties, the sidewalk is in excellent condition in front of Greg Grant Park (Figure 74). However, while the wide entrance to

Figure 73. Vegetation growing between sidewalk panels.

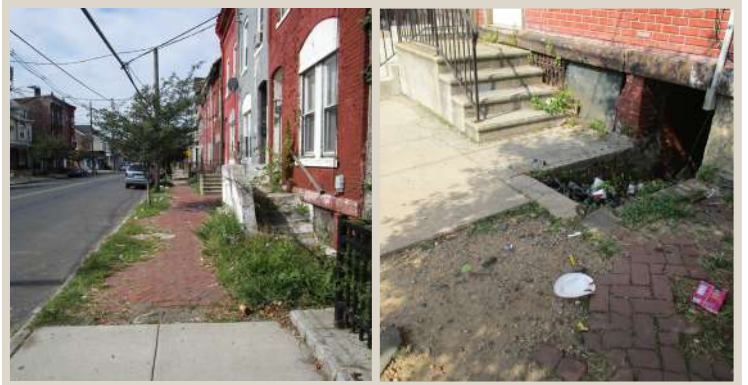
Figure 75. Gaps between varying sidewalk materials.

the park seems like a natural location to cross East State Street, no crosswalk is provided. South of the park, the sidewalk alternates between brick and concrete, with gaps between the different paving types (Figure 75).

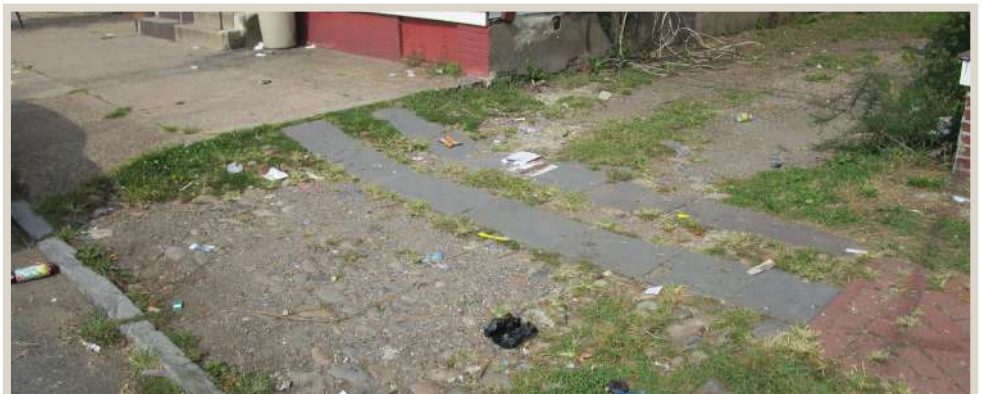
The next block has denser housing development than the previous stretches, with multiple three-story brick apartment buildings. The housing stock appears to be in poor condition, but most appear to be inhabited. Litter was observed throughout this stretch. On both sides of the street, the sidewalk is in decent condition, except for where it changes from concrete to another material such as brick or stone. Additionally, there is a driveway that interrupts the sidewalk on the west side (Figure 77).

Figure 77. Driveway interrupts sidewalk.

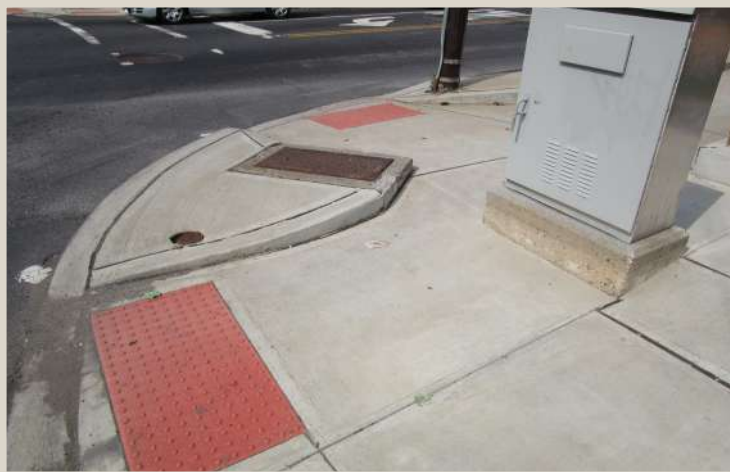
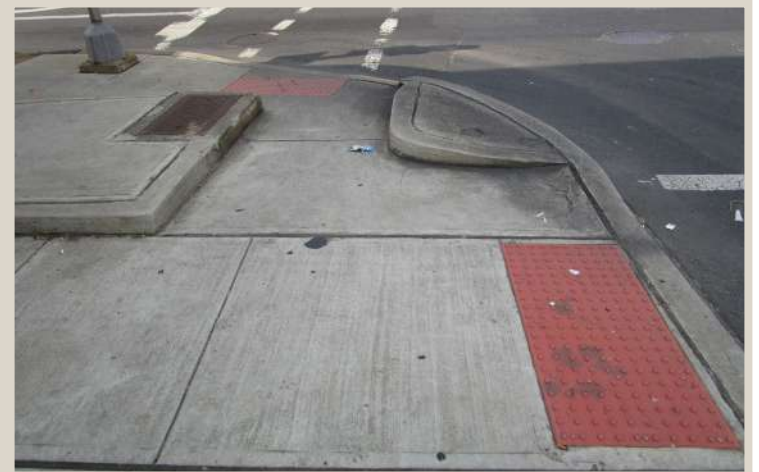
All four corners have curb ramps which appear relatively new. However, these ramps were retrofitted into an intersection with existing utility poles, drains, and electrical substations. As such, the ramps may not be ADA compliant because they feature odd slopes and lack the appropriately sized landing pads for wheelchair users (Figure 79). All four corners have significant features

Figure 79. Retrofitted curb ramps at the Chambers Street intersection.

that narrow the sidewalks. Any improvements would likely require completely replacing the traffic signals and widening sections of the sidewalk into the parking lane. Standard crosswalks are painted in all directions that match the orientation of the ramps.

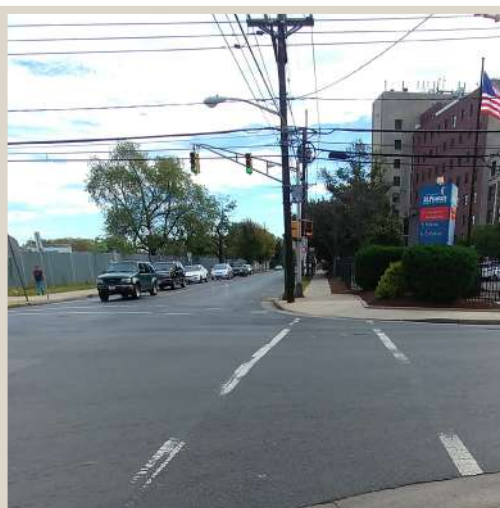
Figure 82. Faded crosswalks near hospital.

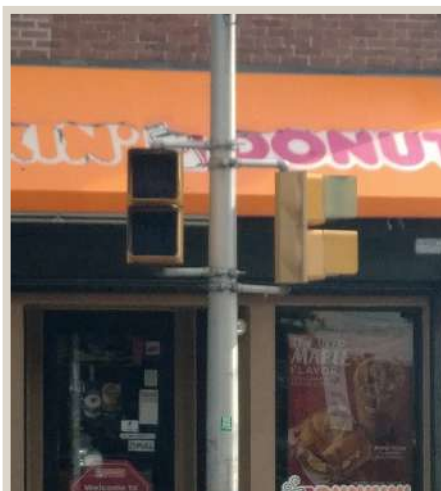
Automatic pedestrian signals exist on all four sides, but they are a mixture of older text based (walk/don't walk) and new symbol based designs. At the time of observation, the pedestrian signal on the northeast corner was not functional (Figure 82). All four legs of the intersection have parallel crosswalks that are in good condition. The corner ramps at this intersection all appear to have been redone recently; they are ADA compliant and have truncated domes. The ramps on the southeast corner do not directly orient pedestrians into the crosswalk, which can be a problem for pedestrians with visual impairments (Figure 83).

Figure 83. Non-functioning pedestrian signal

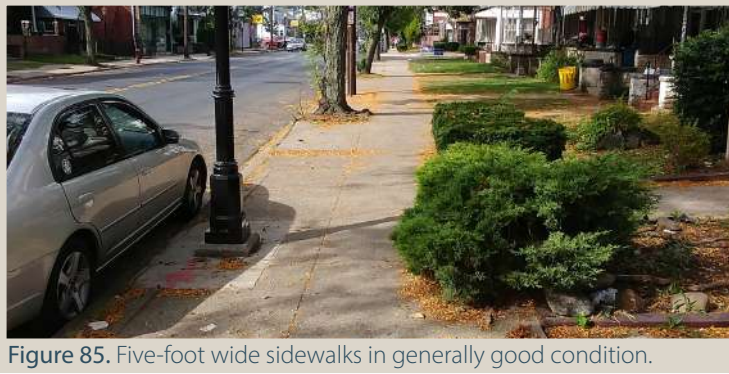
Figure 85. Five-foot wide sidewalks in generally good condition.

West of this intersection, Hamilton Avenue is lined with well-kept residences, some with professional services on the first floor. The sidewalk continues to be five feet wide and in generally good condition except where a tree has raised a concrete block (Figure 85).

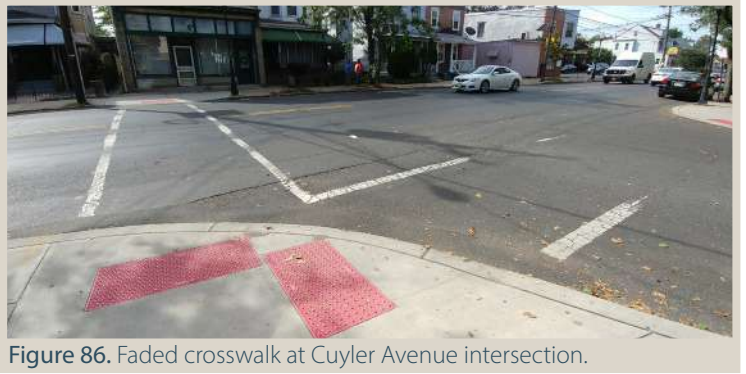
Figure 86. Faded crosswalk at Cuyler Avenue intersection.

Cuyler Avenue arrives from the north, terminating on Hamilton Avenue. There is a crosswalk across Cuyler, and also a single crosswalk across Hamilton Avenue, on the eastern leg (Figure 86). The crosswalk is accompanied by recently installed curb ramps that appear to be fully ADA compliant. An overhead light sits directly above the crosswalk; however, the crosswalk striping is faded and there are no crosswalk signs in either direction. NJ Transit bus stops are located on both sides of this intersection and have suitable sidewalks for boarding passengers.

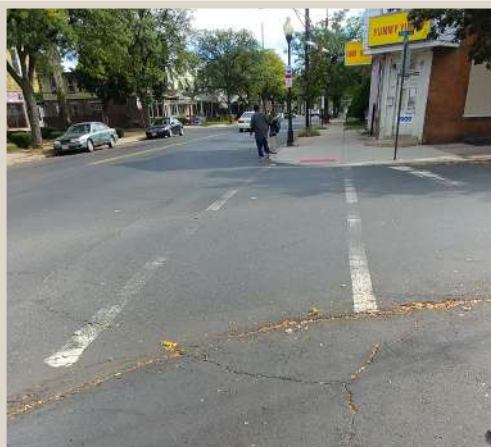
Park Avenue meets Hamilton Avenue just 125 feet to the west of the Cuyler Avenue intersection. The intersection has one parallel crosswalk to cross Park Avenue but no marked crosswalk across Hamilton Avenue. The southeast corner has a recently built ADA compliant ramp with correctly positioned truncated domes. The southwest corner has no sidewalk at all, but instead a continuous asphalt surface from an auto repair business parking lot. While pedestrians can use the parking lot to walk, it is likely that cars are frequently parked in the way (Figure 87).

Figure 87. Missing sidewalks along Hamilton Avenue.

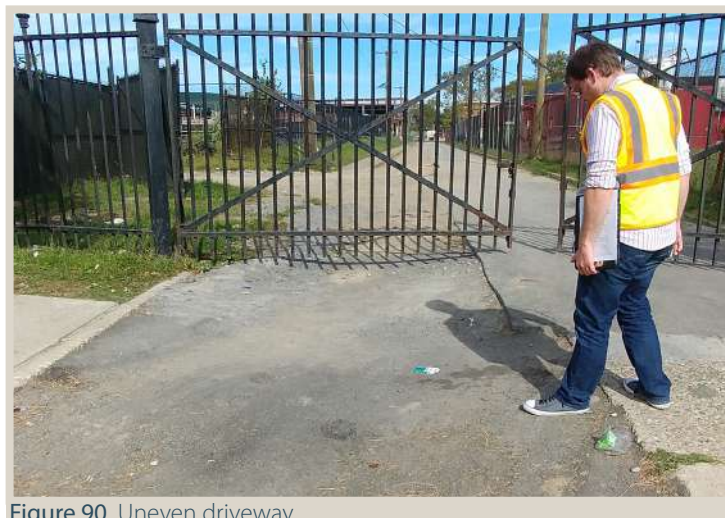
Further west, the homes on the south side of Hamilton give way to a parking lot for the St. Francis Medical Center. In combination with the high school athletic fields, the road appears to be wider and emptier as there are no buildings on either side. Across from the parking lot there is an alley that separates the school grounds in two, although it is fenced. The sidewalk at this alley is uneven (Figure 90).

Figure 90. Uneven driveway.

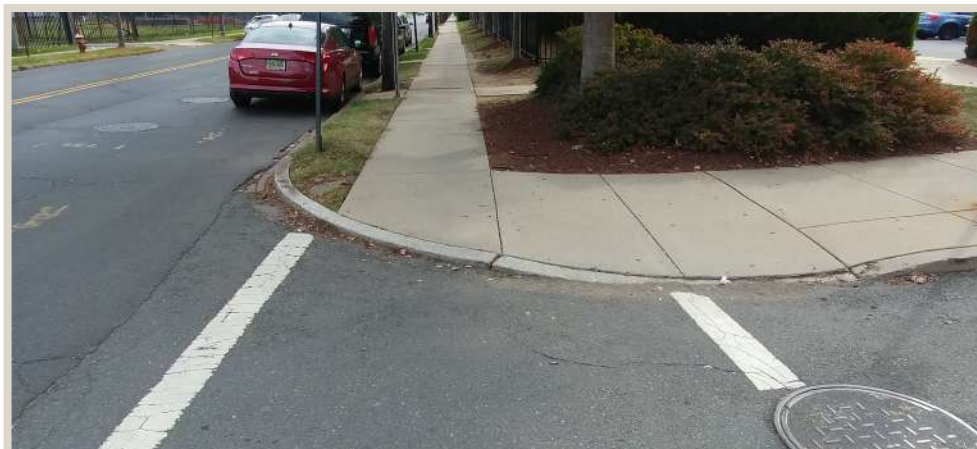
The hospital parking lot is separated from the main complex by Bert Avenue, which runs one-way southbound. Unlike the previous intersections, the curb ramps have not been rebuilt and are not compliant with ADA, due to their slope and lack of truncated domes

Figure 91. Non-compliant ADA ramps.

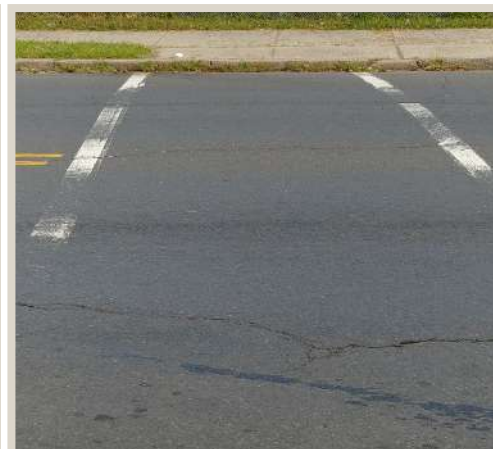
(Figure 91). A faded crosswalk is painted across Bart Avenue, and there is a single faded crosswalk across Hamilton. The crosswalk for Hamilton does not have a curb ramp on the northern side (Figure 92). Additionally, there are no signs noting this presence of pedestrians. There is a sign stating that parking is not allowed due to a bus stop, but there is no corresponding sign noting which bus route stops here, if any.

Figure 92. Faded crosswalk.

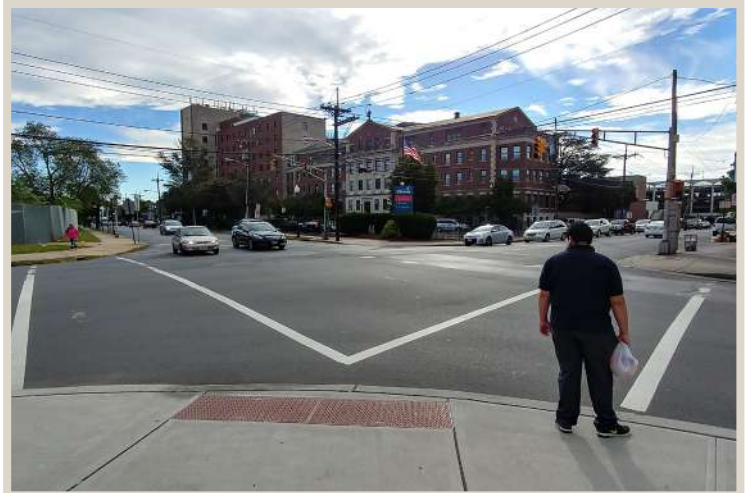
Older text based pedestrian signals exist on all four corners and automatically activate for each cycle. Crosswalks are striped with standard parallel lines, although the paint is faded in parts. All four corners have a single curb ramp oriented diagonally into the center of the intersection, and only the ramp on the northwest corner meets ADA standards (Figure 94). There are signs in all directions pointing at the crosswalks, but they do not highlight the presence of the high school.

Figure 94. Only one ramp at intersection meets ADA standards.

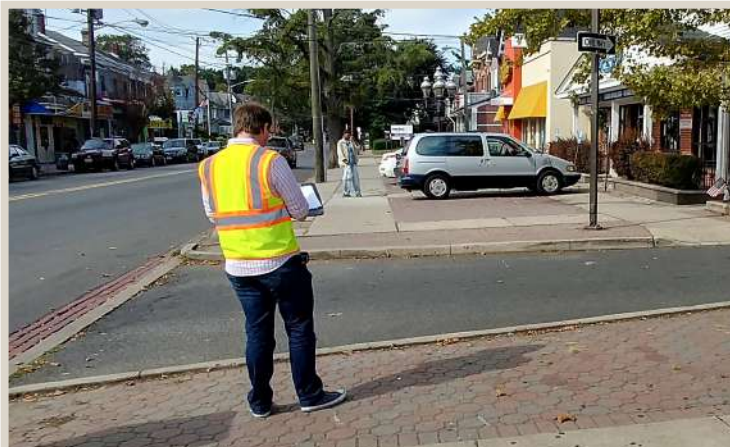
of small businesses that have parking spaces between the sidewalk and the building. Although the sidewalk is appropriately sloped, vehicles that do not pull in all the way block the walkway (Figure 95). The south side of Hamilton has mixed-use buildings with small shops on the first floor. The sidewalk is slightly wider, and the landscape area has been paved with brick.

Figure 95. Parking between sidewalk and storefronts.
