Complete Streets in the City of Trenton: Existing Conditions Analysis

May 2018

Prepared for:
The Trenton Health Team

Prepared by:
**The Alan M. Voorhees
Transportation Center**
Edward J. Bloustein School of
Planning and Public Policy
Rutgers, The State
University of
New Jersey

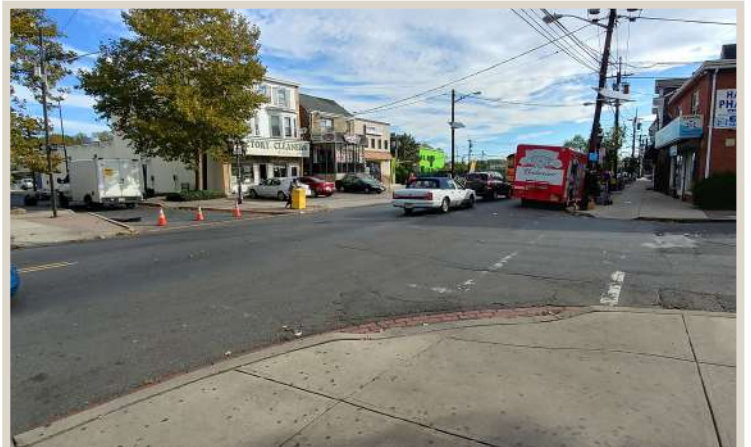
Franklin Street meets Hamilton Avenue from the south. There are curb ramps in decent shape, but they are not ADA-compliant due to their slope and lack of truncated domes. A crosswalk at this location is extremely faded, with no crosswalk over Hamilton Avenue. Across the street, Franklin Street appears to continue as a private driveway into a parking area (Figure 96). The curb ramps are set back around 20-feet, and are not ADA compliant.

Figure 96. Franklin Street intersection.

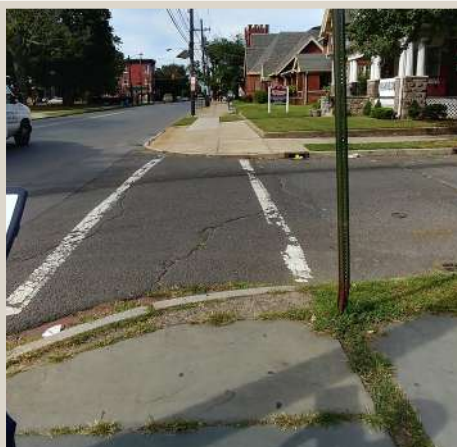
Figure 99. Missing curb ramps.

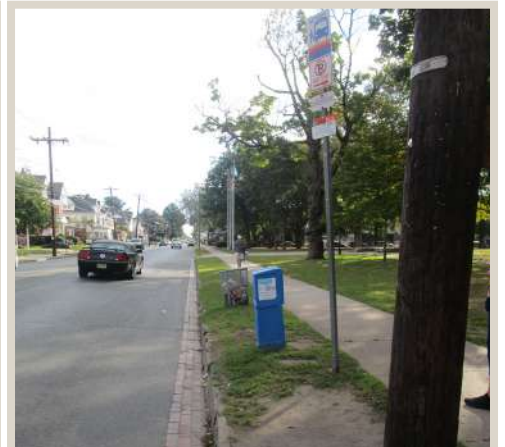
Figure 101. Bus stop with challenging access.

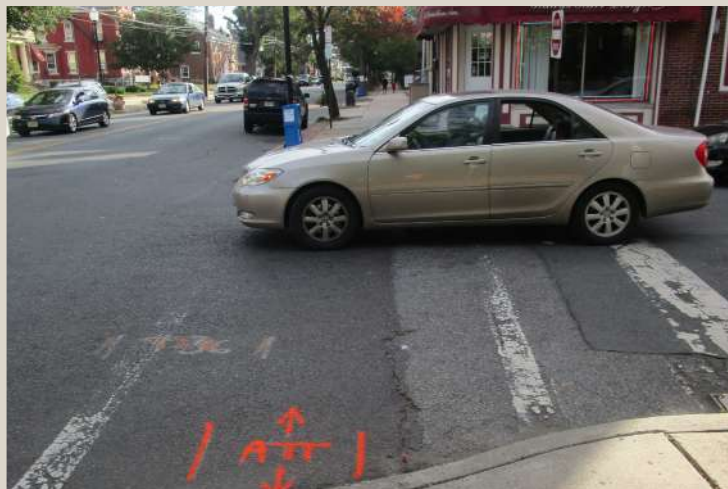
Figure 102. Drivers often block the crosswalk at this intersection.

Whittaker Avenue arrives from the south, carrying traffic one way. There are curb ramps in good condition, but they are not fully ADA compliant. A badly faded crosswalk is marked across Whittaker Avenue, but not Hamilton Avenue. Poor driver behavior was observed

here, as most drivers completely blocked the crosswalk while they waited for a chance to turn onto Hamilton Avenue (Figure 102). A westbound NJ Transit stop sits on the north side of Hamilton. Although the sidewalk does extend to the curb, there are two empty tree wells that may present a tripping hazard. There is no corresponding eastbound bus stop.

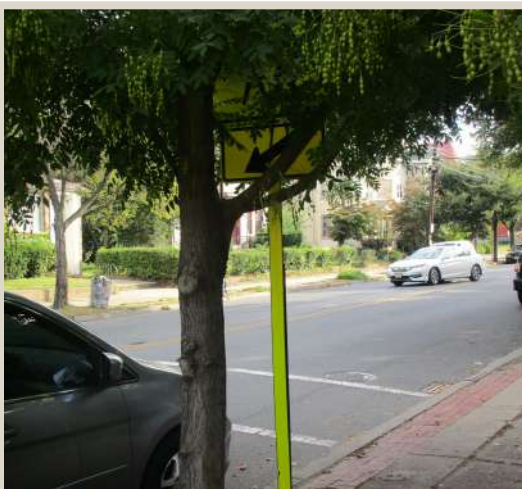
Just 125 feet to the west, Benton Street begins on the northern side of Hamilton Avenue. Here there is a single marked crosswalk across Hamilton Avenue, but it does not have curb ramps on either end (Figure 103). There are two signs marking the traffic, but they are only visible to eastbound traffic. Additionally, one of the signs is almost completely enveloped by a tree canopy, and a driver was parked illegally, further blocking the view of the crosswalk (Figure 104). At the time of the audit, a crossing guard was posted.

Figure 104. Poorly placed crosswalk sign.

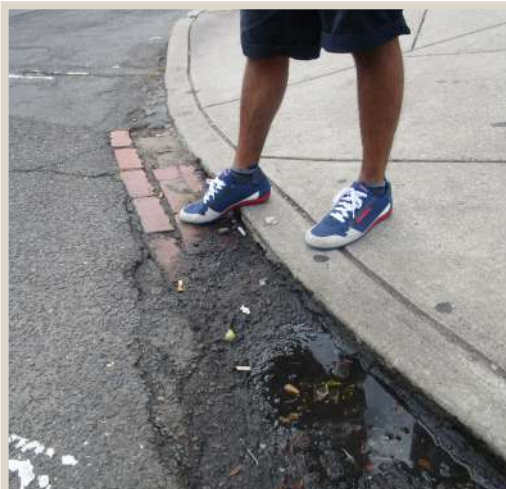
Figure 105. Compromised curb ramp.

Adjacent to the church, Hudson Street runs one-way south from Hamilton Avenue. There are curb ramps across Hudson Street that are in good condition, but lack truncated domes. The curb ramp on the southwest corner is further compromised by asphalt that has eroded, exposing brick (Figure 105). The pavement

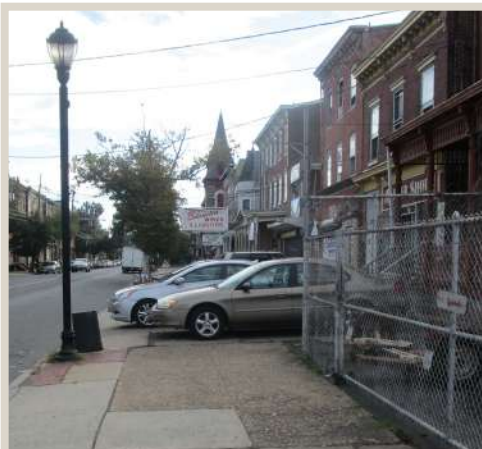
On the south side of Hamilton, there is a small section where the concrete sidewalk has been reduced to gravel. Just past this section, there are a series of businesses that are set back from the street, but use the sidewalk as parking. This results in blockage of the entire sidewalk (Figure 108). Further down the block, a couple of vacant properties have large quantities of litter in their vicinity.

Figure 108. Cars fully blocking sidewalk.

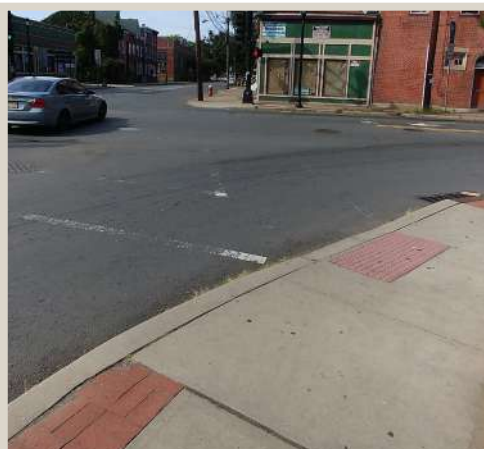
The intersection with South Clinton Avenue is controlled by a traffic signal. All four directions have a left turn lane with a dedicated left turn signal. Additionally, large street name signs are suspended on the traffic signal, making navigation easy at this intersection. All four directions have modern pedestrian signal heads. The buttons to activate the signals on the southeast corner were installed facing the wrong direction. The crosswalk striping is in very poor condition in all directions and is entirely missing on the southern leg. The southeast corner has two curb ramps with truncated domes, but the concrete is cracked. The northeast corner has only a single ramp and a very wide turning radius (Figure 109). The northwest corner has a single curb ramp, and the southwest corner

Figure 109. Wide turning radius.

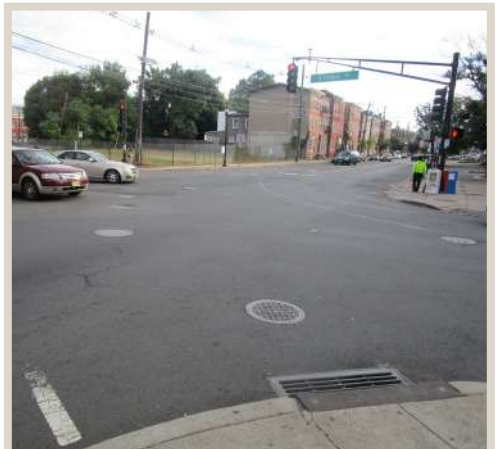
Figure 110. Non-compliant ramps.

has two, none of which are compliant (Figure 110).

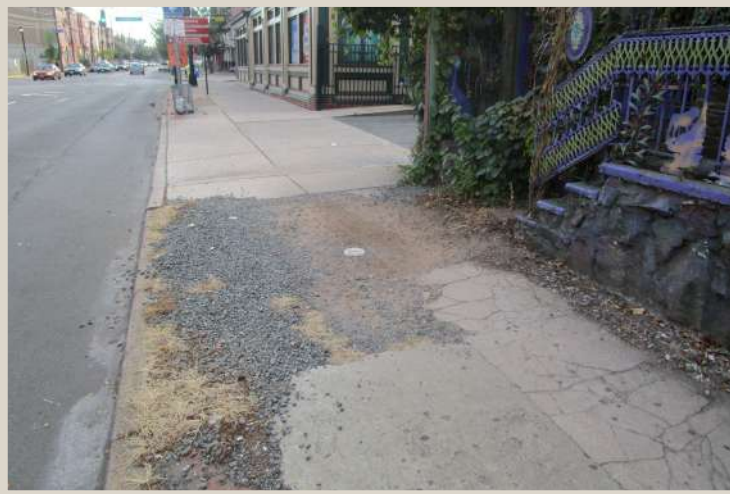
Figure 111. Sidewalk reduced to gravel.

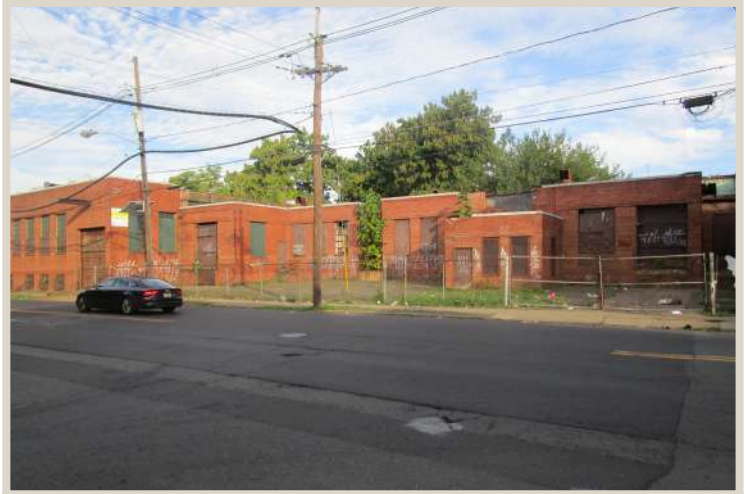
Figure 112. Vacant buildings are common in this section.

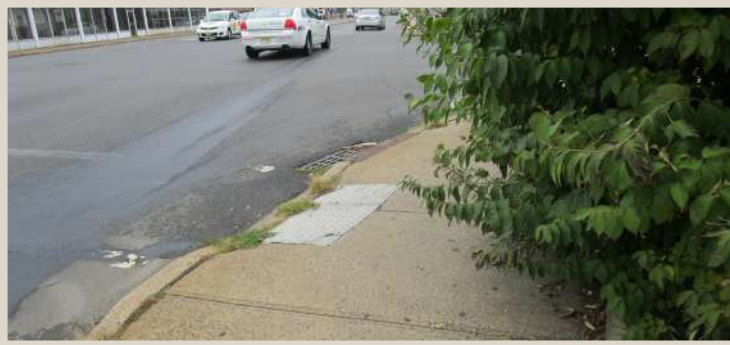
The northern leg of the intersection has no infrastructure for pedestrians. There is no painted crosswalk, no curb ramps, and no pedestrian signal heads. A small traffic island, where pedestrians could theoretically wait, is instead filled with a utility pole, a traffic signal pole, and an electrical control box. The western leg of the intersection does have pedestrian signals and curb ramps, but no striped crosswalk. When built, the curb ramps were likely ADA-compliant, but a lack of maintenance means they are no longer fully accessible.

Figure 115. Non-compliant ramp with a bush blocking visibility.

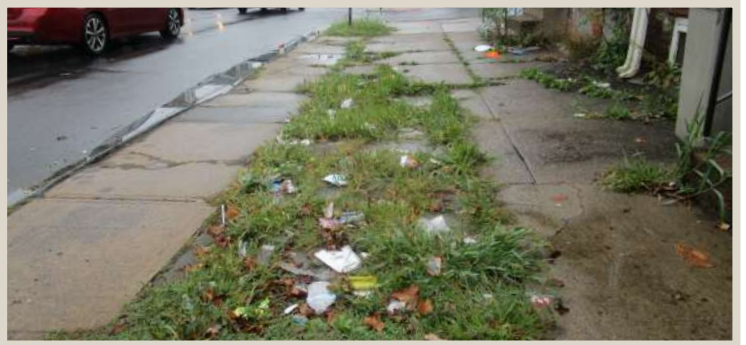
Figure 116. Missing sidewalk with litter.

sections completely missing on the west side (Figure 116). Additionally, plants from an inhabited home have been allowed to completely overgrow the sidewalk on the east side (Figure 117). Lighting is provided by standard overhead cobra fixtures.

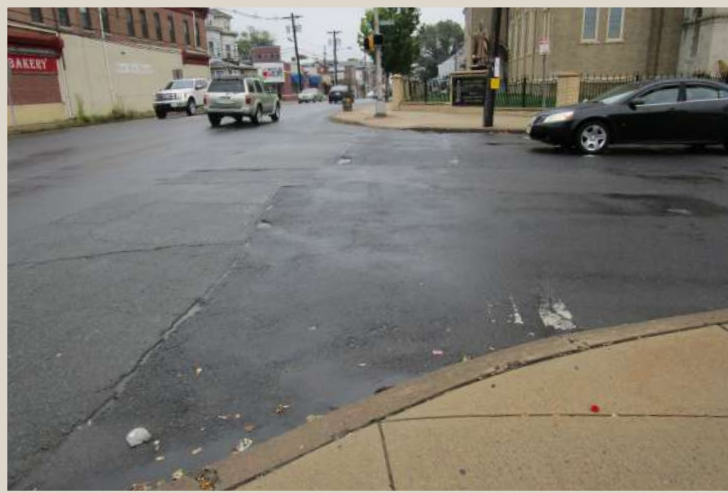
Figure 118. Severely faded crosswalk and stop lines.

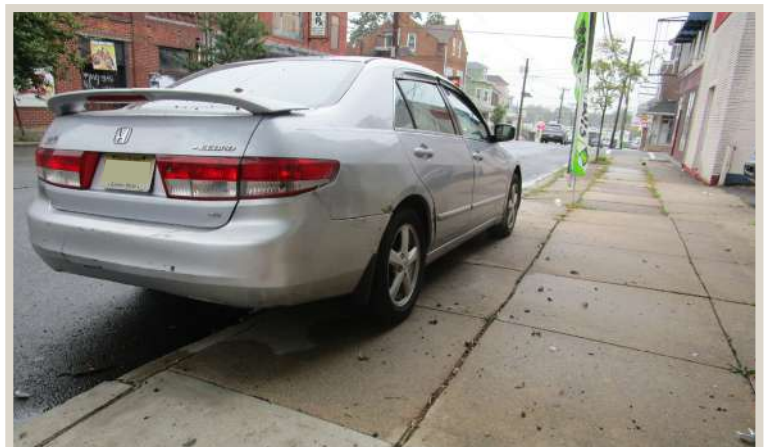
Although the width of the roadway has not changed, parking is legal in some sections, but signage is very inconsistent as to where it is allowed. Because of the sub-standard roadway width, drivers continue to park partially on the sidewalk so their car does not get hit by other vehicles (Figure 120). Another alley, Burgner Alley, crosses North Olden Avenue. On the east side, there are curb ramps and a crosswalk, while on the west side, the sidewalk continues across the alley. There is no signage indicating if the alley is one-way or bi-directional.

Figure 120. Cars regularly park on the sidewalk.

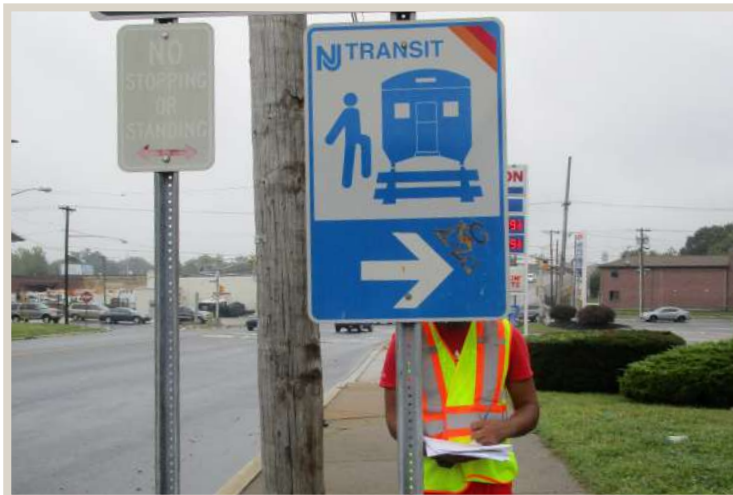
Figure 121. Faded and low-set signage.

The intersection of North Olden Avenue and New York Avenue is very wide and lacks the dense urban neighborhood feel of previous intersections along the corridor. For southbound traffic, North Olden Avenue widens to three lanes: a left turn lane, a through lane, and a right turn lane. Additionally, northbound traffic is only striped as one lane, but is three lanes wide, thanks to a right-turn slip lane from New York Avenue. All four directions of traffic have dedicated left turn signals. The New York Avenue slip lane is not signalized, and is yield controlled. To the west, New York Avenue has an on-ramp to southbound Route 1, and an off-ramp from northbound Route 1. To the east, there is an off-ramp for traffic going southbound on Route 1. As such, it is likely that this intersection sees heavy traffic. A sign placed before the intersection directs drivers towards the Trenton Transit Station, via Route 1 (Figure 121). A “no parking” sign on the same post is badly faded.

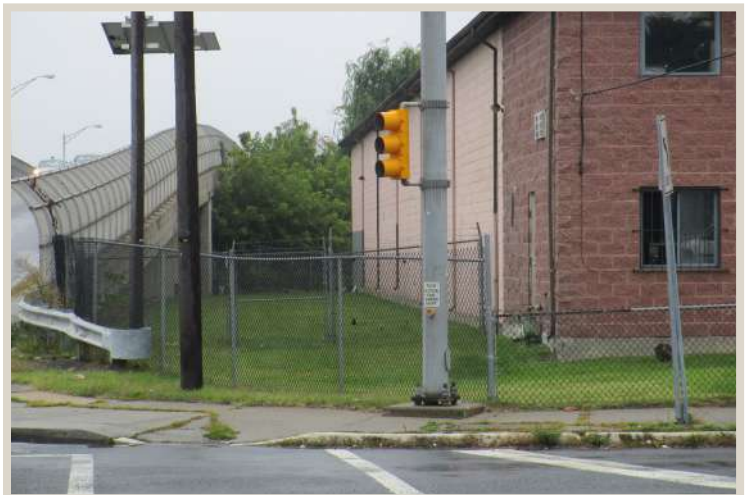
Figure 122. Busy intersection lacks pedestrian signals.

button that says it will provide a green light (Figure 122). Each crosswalk has a curb ramp, but none of them are ADA compliant (Figure 123). The turning radius on all corners is wide, encouraging higher speeds. Overhead lighting is not adequate for the width of this intersection.

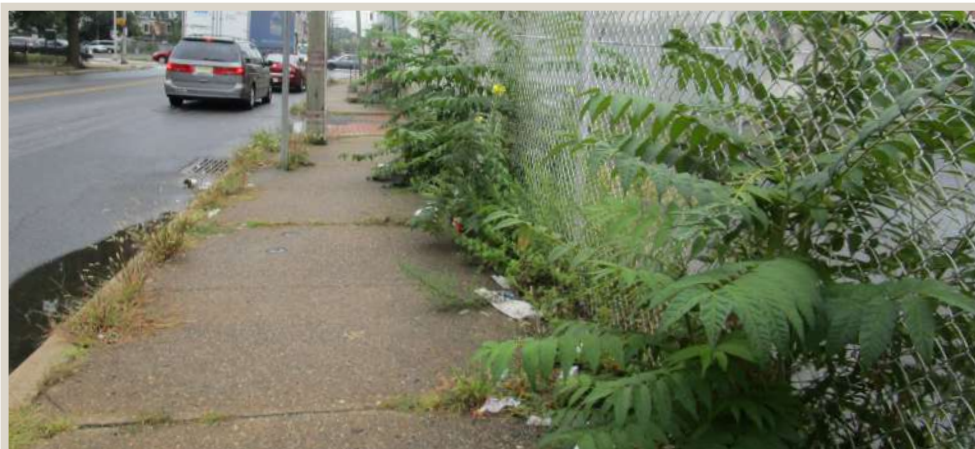
Prince Street, while not as freshly paved as St Joes Avenue, has a suitable road surface, a painted crosswalk, and appropriate curb ramps. South of the intersection, a school crossing sign is posted for southbound traffic next to an empty lot. There is overgrown brush blocking parts of the sidewalk from this same lot (Figure 126). Past this lot, Agnes Avenue, an alley, arrives on both sides of North Olden Avenue. Instead of a painted crosswalk, the end of this alley is paved in a bright red brick, in contrast to cobblestone used further down the alley (which is mostly covered in asphalt patches). While the brick is visible, there are no curb ramps for pedestrians (Figure 127).

Figure 126. Overgrown brush blocking portions of the sidewalk.

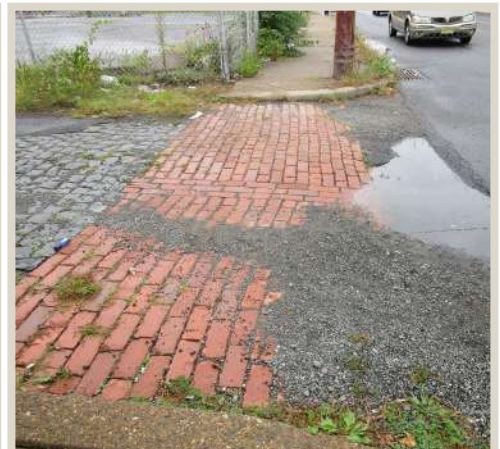
Figure 127. Missing curb ramps.

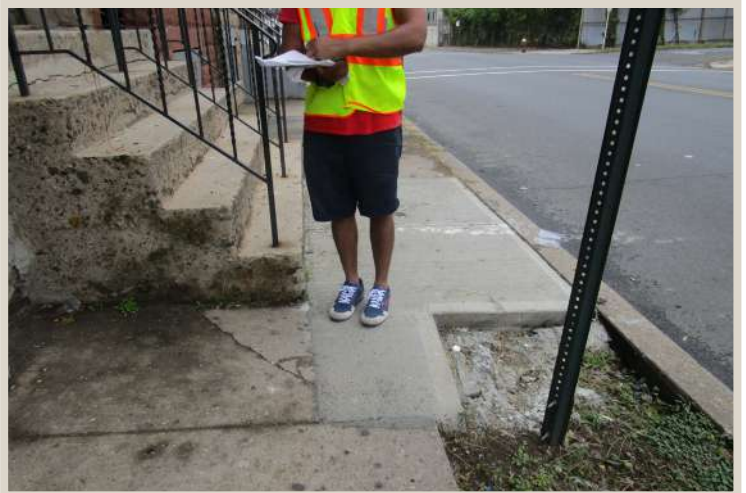
Figure 129. Signage and stairs create a narrow walkway.

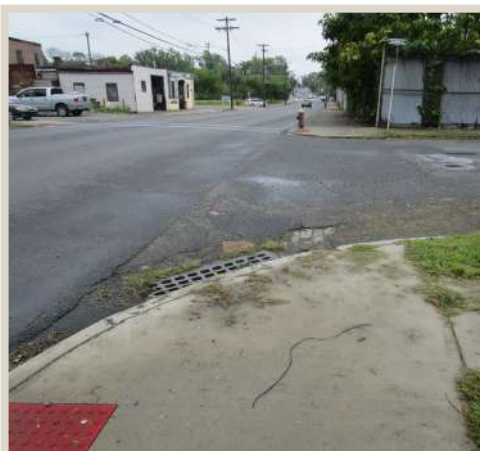
Figure 130. Missing curb ramps.

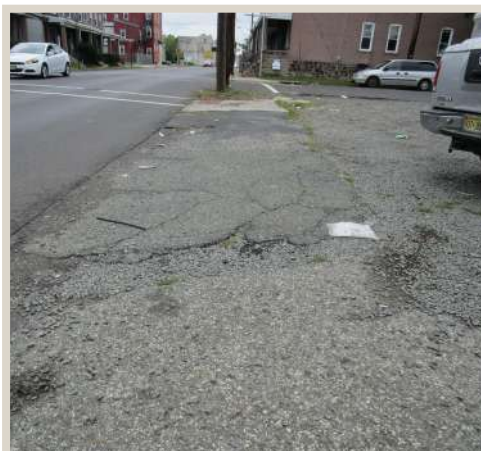
Figure 131. Missing sidewalk.

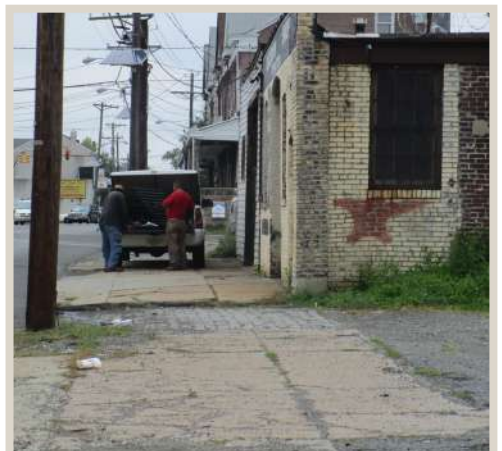
Figure 132. Cars regularly park on the sidewalk.

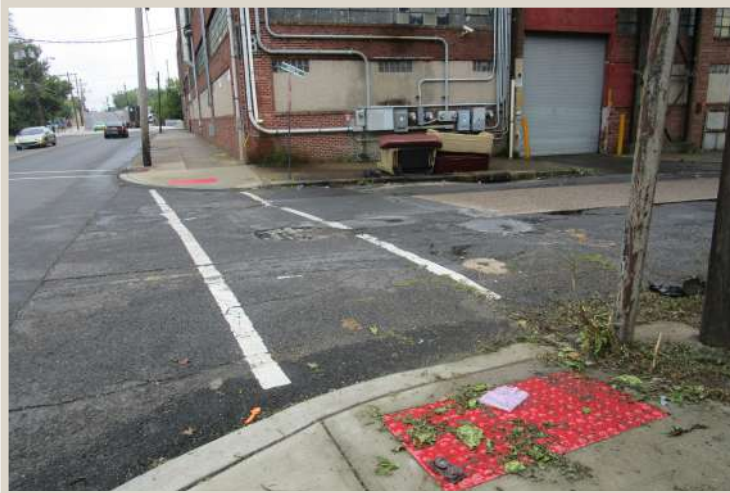
Figure 133. Grass clippings cover truncated dome across from abandoned building.

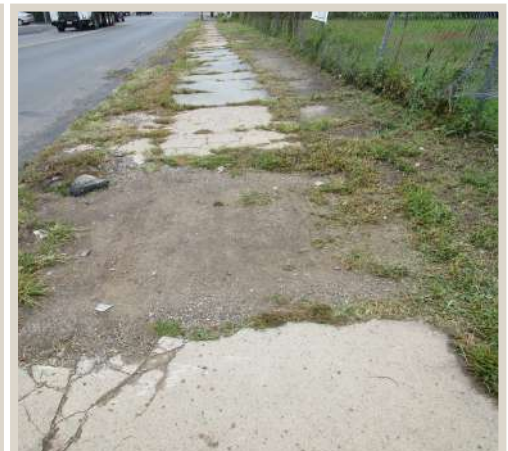
Figure 136. Missing sidewalk.

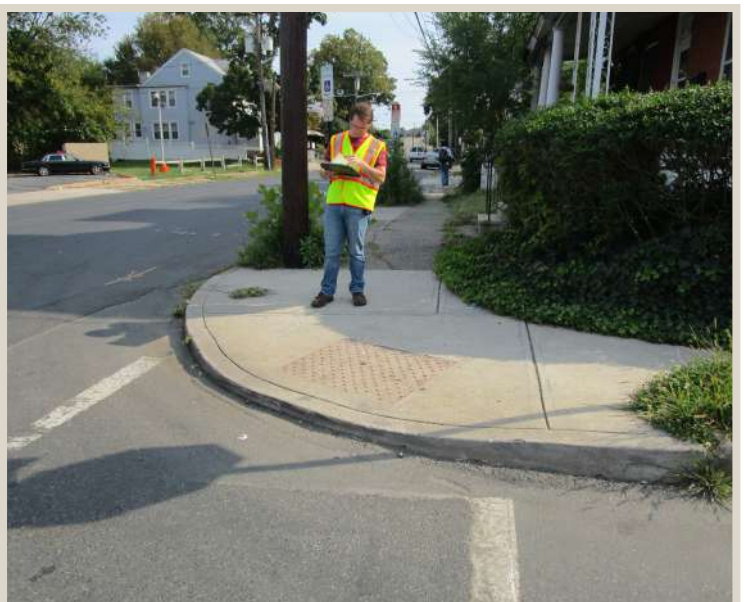
South of the bus stops, Moreland Avenue intersects from the west at a stop sign. There is a marked crosswalk across this small roadway. The corners have attempts at diagonal curb ramps, but there is a very large gap between the bottom of the concrete ramp and the asphalt, making them inaccessible (Figure 140).

Figure 140. Large gap between bottom of ramp and roadway.

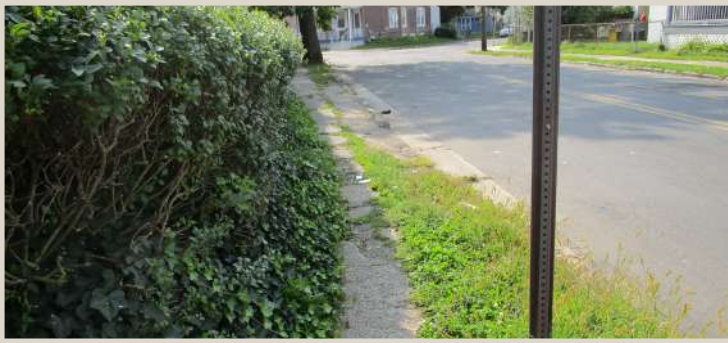
Figure 141. Overgrown plants blocking sidewalk.

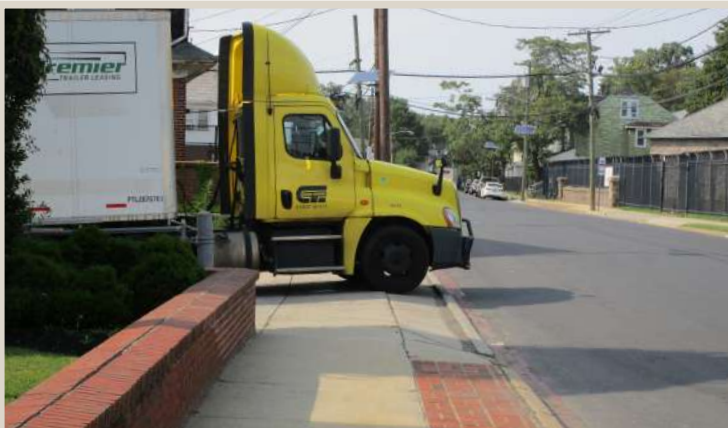
A tenth of a mile to the south, Pennington Avenue intersects with Arlington Avenue on the east side and Coolidge Avenue on the west side at an offset intersection. There are no marked crosswalks in any direction. On the Arlington Avenue side, there are no curb ramps. There are two diagonal curb ramps on the west side that are ADA compliant except for large amounts of gravel at the base of the ramps. Sidewalk conditions improve south of the intersection, but are still inconsistent from property to property. Vehicles parked in residential driveways were observed blocking the sidewalk (Figure 143). The sidewalk is in excellent condition in front of the Courtney Temple.

Figure 143. Vehicles frequently park blocking the sidewalks.

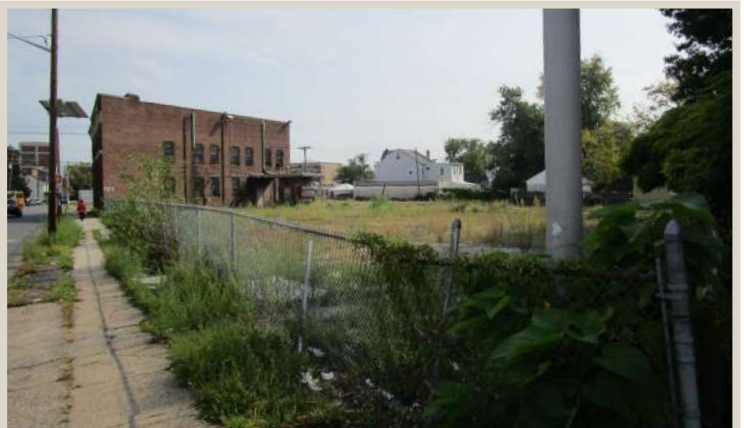
Just south of that facility is Norman Avenue. As with Mellon Street, the intersection has two curb ramps only on the west side, with a faded crosswalk and stop bar. Entering Norman Avenue, the sidewalk is obstructed by overgrown bushes. Alden Avenue, the next street, is very similar, except that it runs one-way into Pennington. South of Alden Avenue, the sidewalk conditions deteriorate in front of a vacant parcel (Figure 144).

Figure 144. Overgrown vegetation by vacant parcel.

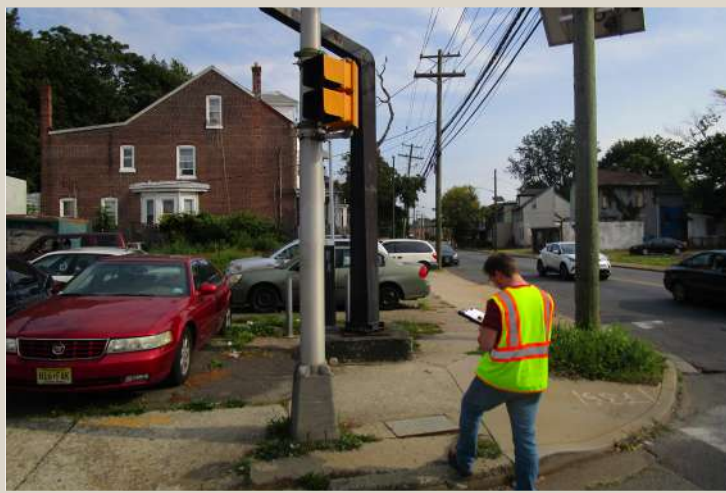
Figure 145. Older, text-based pedestrian signals.

onto Pennington Avenue in both directions. Automatic pedestrian signals are placed in three of the corners, with a mixture of older text based signals and newer models (Figure 145). The northeast corner does not have pedestrian signals and the amount of time given to cross in the other direction did not appear to be adequate.

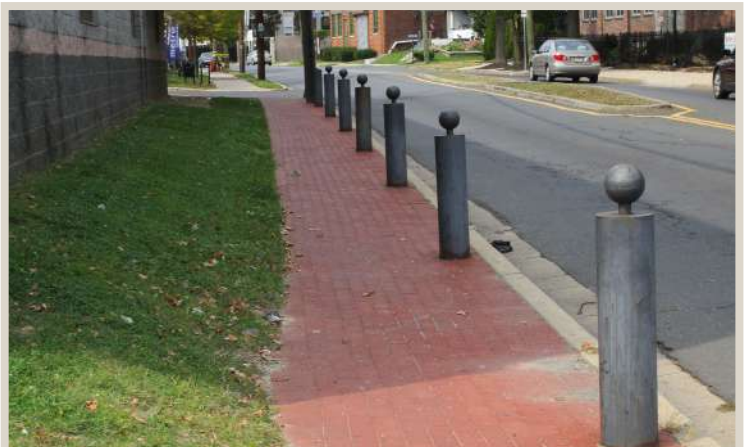
Pennington Avenue narrows slightly where the driveway for the commercial center is located. There is a center median to block left turns both into and out of the center. A curb cut was built into the median to allow pedestrian crossing, even though no crosswalk was painted and the curb ramps are not compliant. However, there is a pedestrian crossing sign visible to northbound traffic. Just south of the median, the sidewalk on the west side is protected by bollards (Figure 152).

Figure 152. Sidewalk protected by bollards.

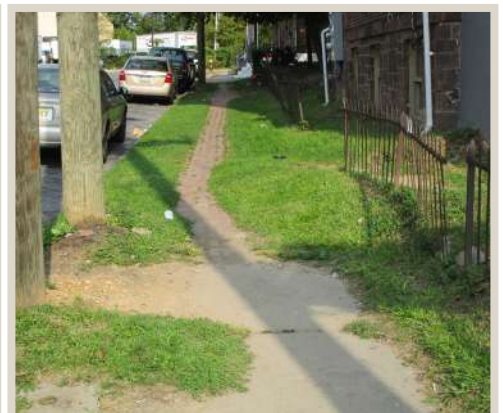
Reservoir Street meets Pennington Avenue at a standard four-way intersection, where Pennington Avenue has the right of way. Only the northwest corner has a modern curb ramp, although it is oriented diagonally into the intersection (Figure 155). The other three corners have curb ramps, but they are not ADA-compliant. There is a faded crosswalk on the western leg, but the other crossings are unmarked. There is only a single overhead light and there is no crosswalk signage. The northbound bus stop is south of the intersection, adjacent to a sidewalk in good condition. The sidewalk along Reservoir Street, continuing east, is in very poor shape (Figure 156).

Figure 156. Sidewalk in poor condition.

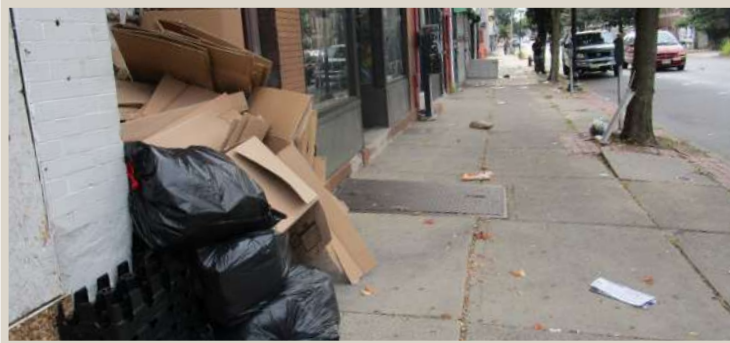
Figure 165. Despite trash cans, litter is found along sidewalk.

is a different style of historic streetlights in this section, although they are very frequent. The north side continues to have a wider sidewalk than the south side, but both are in average condition. Although there is a trash can, litter was observed (Figure 165).

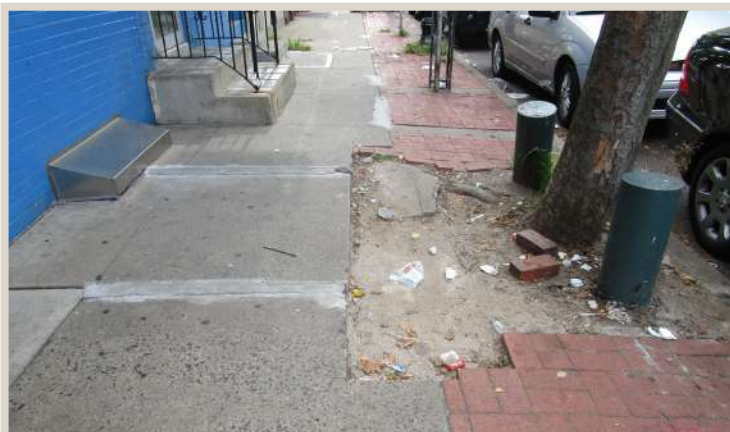
The sidewalk continues in the same manner east of the intersection, although it is the same 5-foot width on each side. There are mature trees, but most tree wells are empty. In a few spots, the sidewalk narrows due to steps from buildings (Figure 167). Watson Street begins

Figure 167. Sidewalk narrows due to unmaintained tree well and stairs.

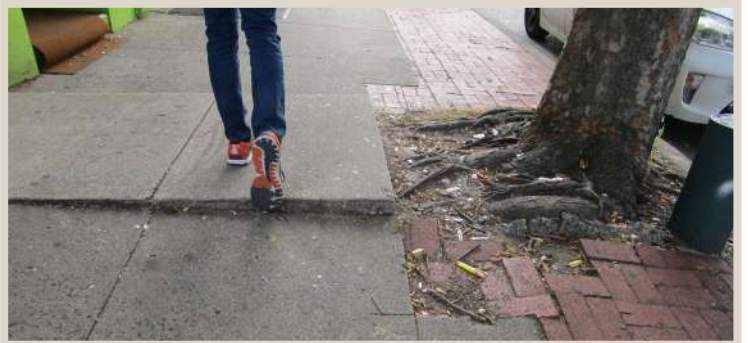
South Broad Street develops the look of a local downtown street in this section. There is one lane in each direction, with street parking, and no centerline. Retail lines both sides of the street, although many of the buildings are in poor condition. The sidewalk has a brick trim, but many locations are cracked or raised (Figure 166). Trashcans are frequent, but litter is everywhere.

Figure 166. Raised sidewalk causes a tripping hazard.

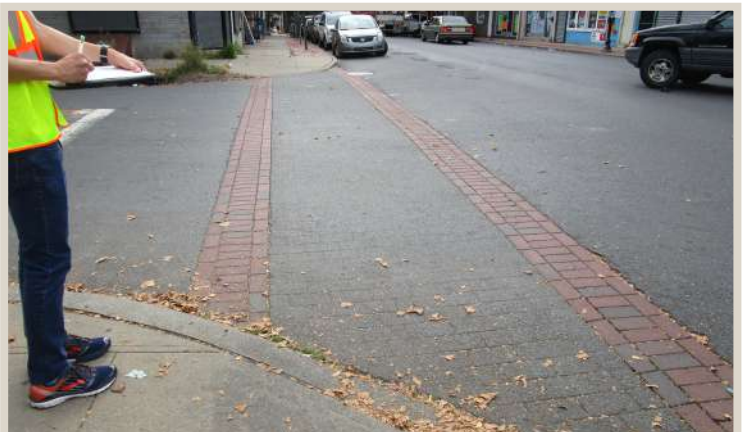
on the south side, running one-way. There are curb ramps with truncated domes, but the slope is not compliant, and there is a single faded crosswalk. Sixty feet away, Roebling Avenue is on the north side. Instead of having painted crosswalk lines, this intersection has a crosswalk outlined in brick (Figure 168). There are non-compliant curb ramps on either side and no crosswalk is provided for crossing South Broad Street.

Figure 168. Crosswalk outlined in brick.

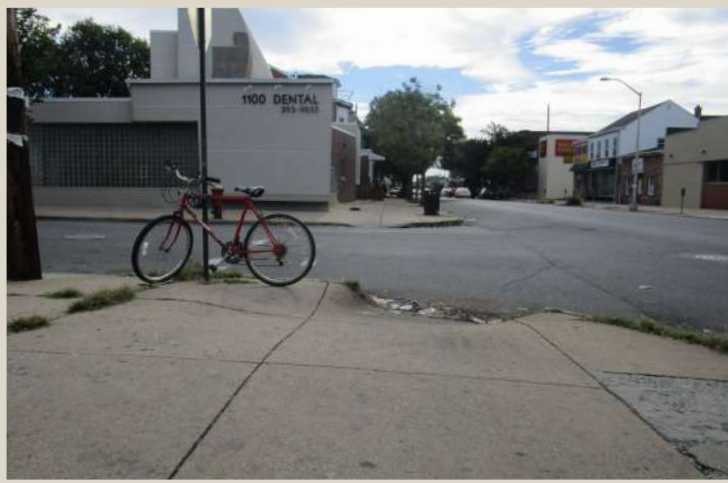
Figure 169. Steep ramp with litter.

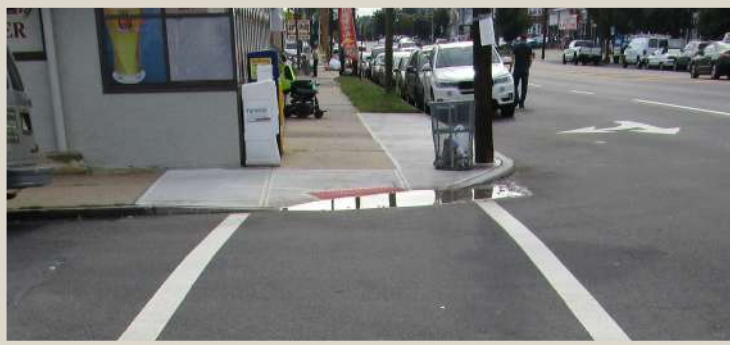
Figure 171. Water pooling at bottom of ramp.

Stanton Street and Remsen Avenue both intersect with South Broad Street at a standard four-way intersection where South Broad Street has the right of way. This means that traffic crossing Broad Street or turning onto it have to navigate five lanes of traffic that do not stop. For pedestrians, there are new ADA-compliant curb ramps and painted crosswalks to cross Stanton Street and Remsen Avenue, but no crossing provided over Broad Street. On the western corner of Stanton Street, an improperly built slope has resulted in pooled water at the base of the curb ramp (Figure 171).

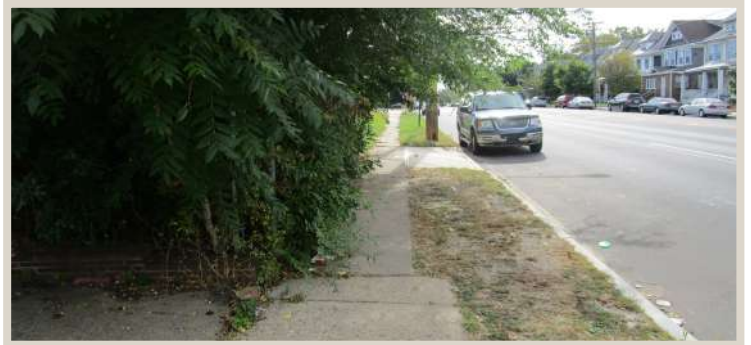
Figure 172. Overgrown bushes minimize usable sidewalk area.

Past the intersection, the sidewalk on the north side of the street is narrowed due to overgrown bushes (Figure 172). The sidewalk continues in decent shape after the intersection. Capner Street terminates on the north side, adjacent to an Investors Bank. The sidewalk in front of the bank is wide and in excellent shape. As with the previous intersections, the curb ramps have recently been rebuilt and are also in excellent shape. There is a crosswalk across Capner Street, but none across South Broad Street.

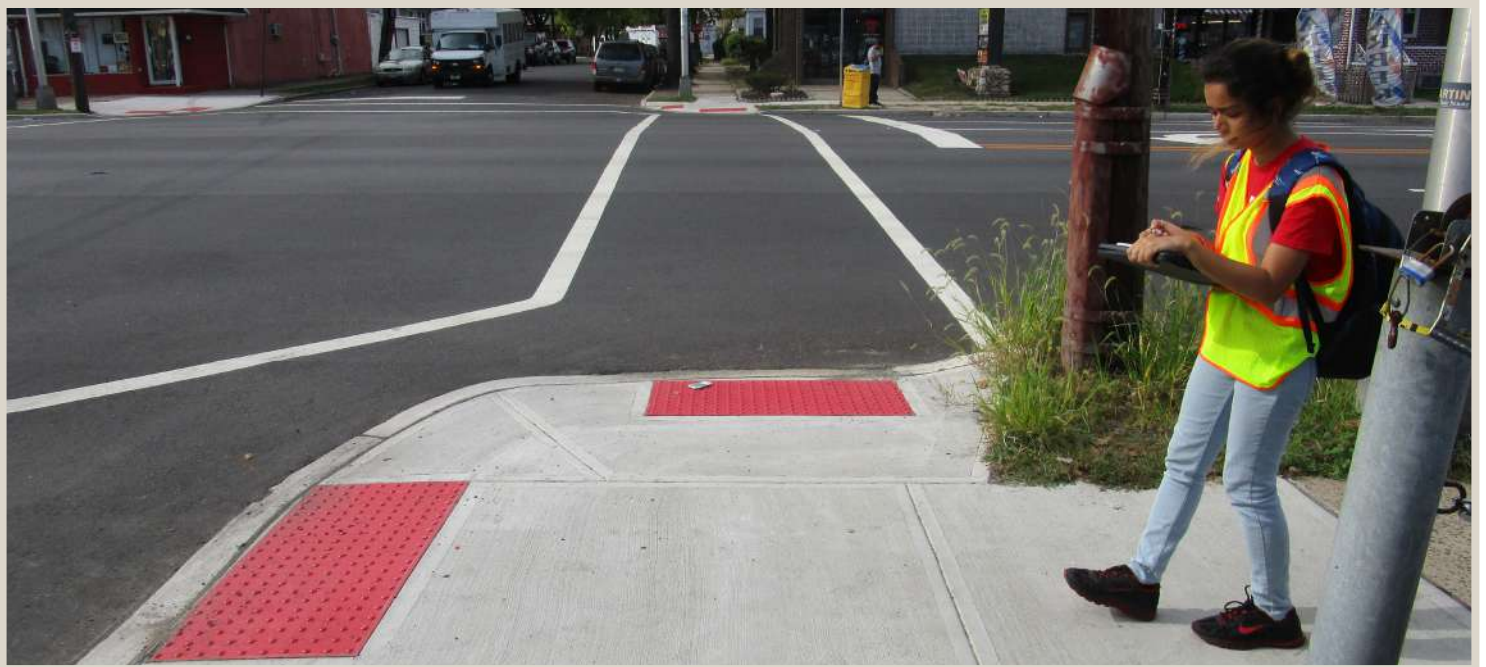
the crosswalks. The crosswalks are striped with parallel lines that are in very good condition (Figure 174 on page 75). However, the intersection is lacking in pedestrian signals. There are left turn lanes for both directions on South Broad Street, but no left turn signal.

Figure 174. Sidewalks and ramps in excellent condition.

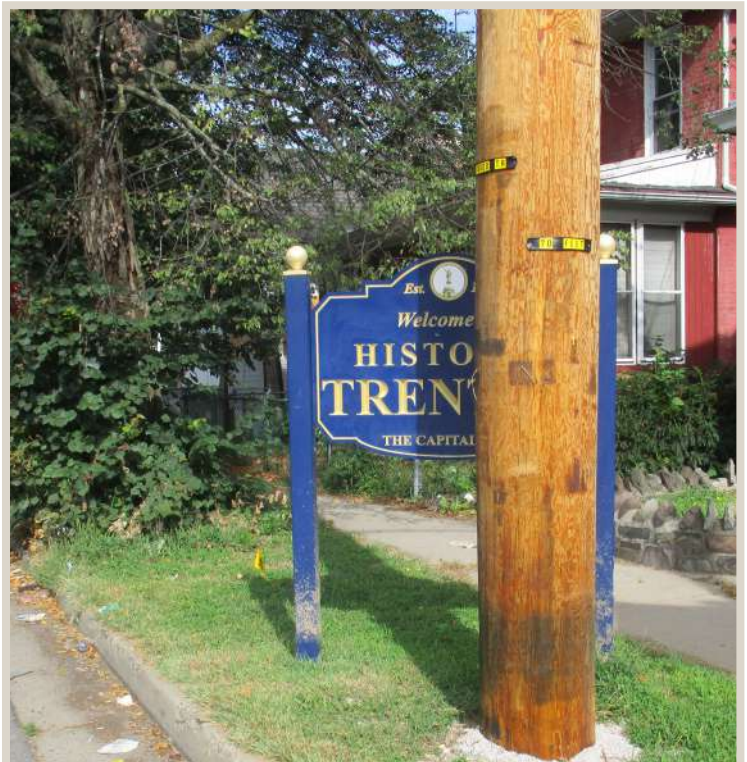
Street that has a planting strip between the curb and the sidewalk. There is no shelter, but there is a trash can. The bus stop on the north side of the street is also located adjacent to a planting strip, although there is a small concrete landing area. The signage is blocked by a tree, and there is another trash can. Vehicles were observed parking at the bus stop (Figure 175). Just east of the bus stop, a brand new utility pole has been installed in a way that completely blocks the “Welcome to Historic Trenton” sign (Figure 176).

Figure 176. Signage blocked by utility pole.

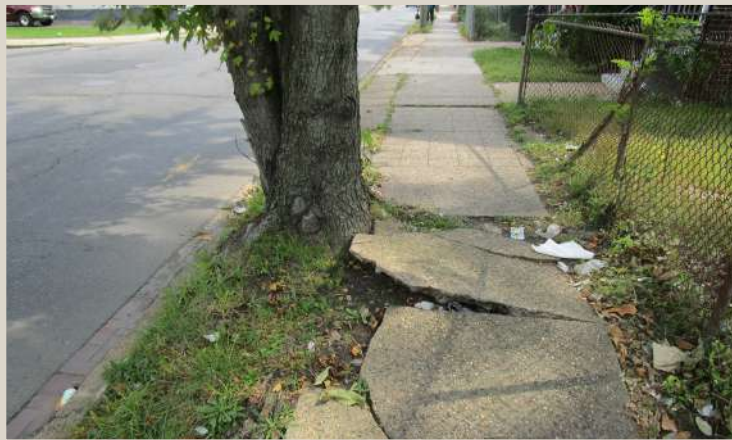
Figure 179. Dangerously uneven sidewalks along Pennington Avenue.

Poor sidewalk conditions were the most common issue noted along the assessed corridors (Figure 179). Cracked, heaved, and broken sidewalks make the city less accessible, especially for parents with strollers, residents with visual impairments, and those who use wheelchairs, canes, or walkers. To encourage more walking, communities must have ADA compliant sidewalks that are level, continuous, free from cracks, and lack obstructions such as signs, garbage cans, cars, and overgrown shrubbery and trees.

Sidewalk width and construction materials are important considerations for improving sidewalk usability. Sidewalks can be surfaced with a variety of materials to accommodate varying budgets and contexts. Safe sidewalk surfaces should be firm, stable, and slip-resistant. Although brick pavers may appeal to some, they can require more maintenance, become slippery in inclement weather, and create tripping hazards. Pavers can also pose a problem to pedestrians in wheelchairs if they settle unevenly or become lifted. Concrete sidewalks last longer and require less maintenance. The Federal Highway Administration (FHWA) recommends a sidewalk width of five feet for two adult pedestrians to comfortably walk side-by-side; at a minimum, all sidewalks should be constructed to this width. In areas with heavier pedestrian traffic such as near parks, schools and centers of commerce, sidewalks should be eight to ten feet wide (Figure 180).³ All streetlights, utility poles, sign posts, mail boxes, benches, and other street furniture should be located out of pedestrian pathway along the sidewalk. When not possible, these obstructions should be located consistently so a clear travel zone is provided for pedestrians with vision impairments and other disabilities.

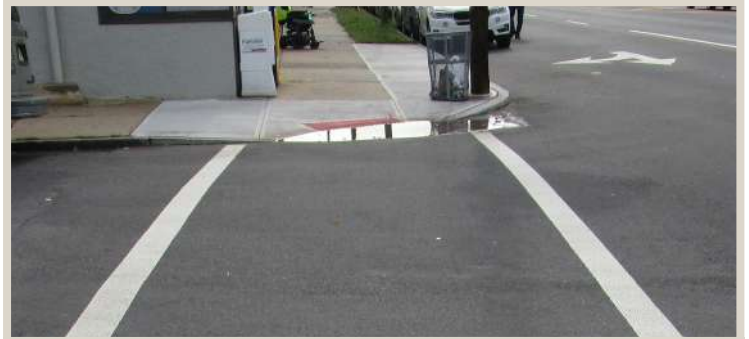
Figure 182. A curb cut which allows water to pool at the bottom is not usable.

ADA guidelines state that curb ramps should be directional wherever possible, where each corner has two ramps installed perpendicular to the face of the curb (vs. a single ramp facing diagonally into the intersection). In order to achieve ADA compliance, curbs cuts must provide a level maneuvering area or landing at the top of the curb ramp, provide a maximum ramp slope of 8.33 percent, and have a detectable warning surface to alert the visually impaired of the transition from the sidewalk to the roadway that extends across the full width of the curb ramp and includes a series of raised, truncated domes in a high contrast color relative to the surrounding sidewalk.⁴

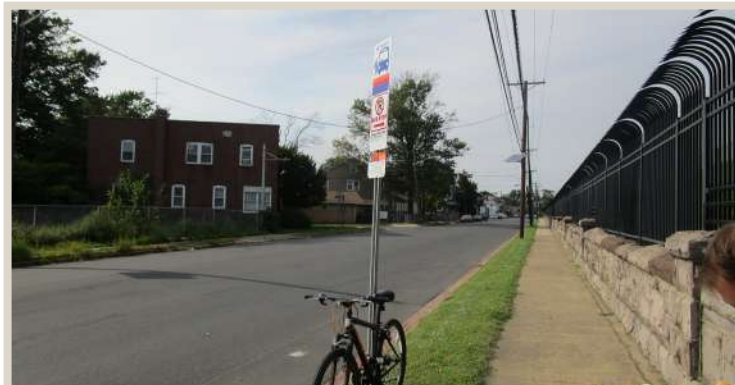
Figure 185. While this bus stop on Pennington Avenue is clearly marked, there are no facilities for bicyclists riding to the stop nor is there a shelter for passengers awaiting their bus.

Many of the bus stops along the studied corridors were marked with poor signage, lacked ADA compliance, and did not provide passenger amenities. Bus shelters not only provide a useful waiting area for passengers, they provide

a highly visible demarcation of bus stop locations. Bus shelters encourage bus ridership by providing passengers with a place to wait and sit in comfort and security, protected from the elements. While bus shelters may not be necessary or appropriate at every bus stop, seating and route information should be considered at all stops along the observed corridors.
